ANALYSIS OF COMMERCIAL CONSTRUCTION METHODS FOR A MULTI-FAMILY
RESIDENTIAL BUILDING WITH PERSONALITY CHARACTERISTICS OF
CONSTRUCTION TEAMS

RACHEL SOMMER
SPRING 2015

A thesis
submitted in partial fulfillment
of the requirements
for a baccalaureate degree
in Architectural Engineering
with honors in Architectural Engineering

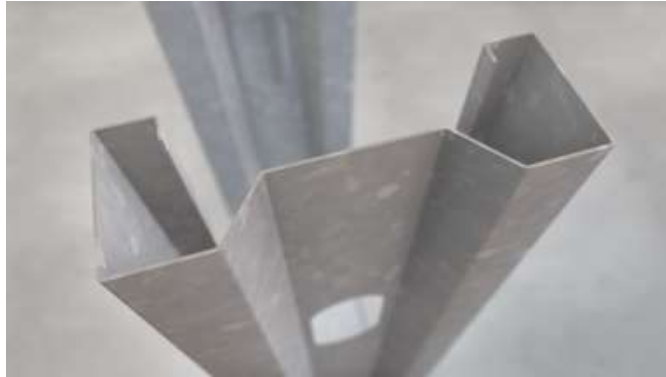
Figure 5: SigmaStud Profile

studs. Structural efficiencies of around 30-40% can be expected over traditional studs when using the Steel Network's Sigma line of products for structural metal stud design.

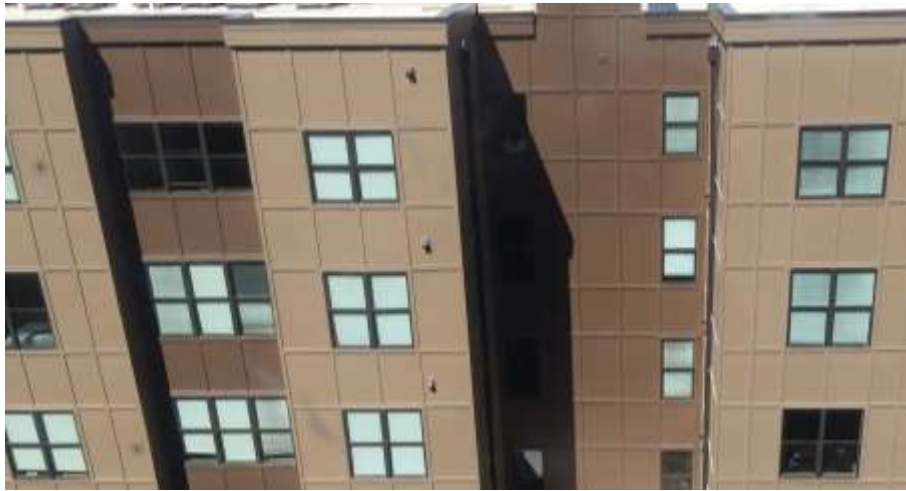
Figure 12: Fiber Cement Color Application

The original façade system used cement fiber panels, specifically the WeatherBoards product manufactured by Certainteed. Each panel came pre-coated with the company's FiberTect Primer/Sealer and was ready for installation upon arriving at the site. The standard panel size was 4' (horizontal) by 8' (vertical), with a 5/16" thickness. Although there are many textures and patterns available for this product, the Plaza specified the standard smooth finish. Two colors of paint were applied to different areas after installation in order to highlight the indented and extruded portions of the exterior shape of the building, as can be seen in Figure 12.

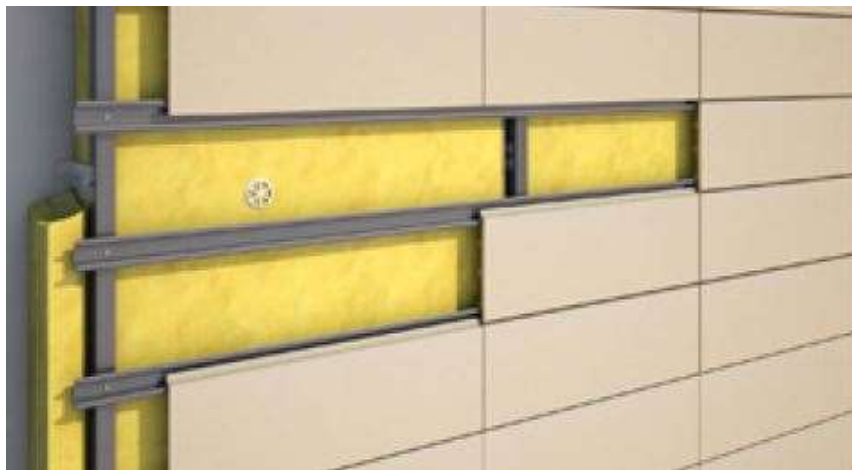
Figure 16: Zephyr Evolution Supports

The installation of a rainscreen system is fairly straightforward. First, the interior assembly is put in place, generally with 2” or 2.5” rigid insulation as the outer layer. Vertical support profiles are attached to the assembly using propriety clips, and horizontal support rails are then attached to the vertical supports (see Figure 16). Although this step is not complicated and usually only involves standard screw connections, it is extremely important that all supports are installed plumb, level, and within location tolerances. This is by far the most time-consuming part of a rainscreen installation, but can be made more efficient with laser levels.

supports, it is extremely easy to remove or replace a damaged panel.

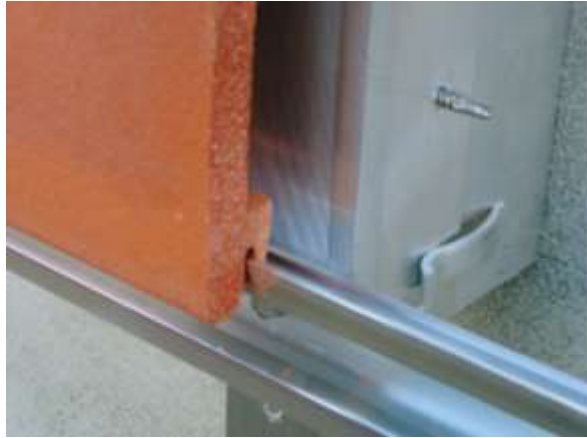
Figure 17: Panel Connection to Supports

Figure 17 shows how Zephir Evolution panels rest on the support rails.
