THE PENNSYLVANIA STATE UNIVERSITY  
SCHREYER HONORS COLLEGE

DEPARTMENT OF BIOMEDICAL ENGINEERING

STUDYING THROMBOSIS AND SURFACE ROUGHNESS IN THE PENN STATE  
PEDIATRIC VENTRICULAR ASSIST DEVICE

CECILIA A. RICHARDSEN  
SPRING 2019

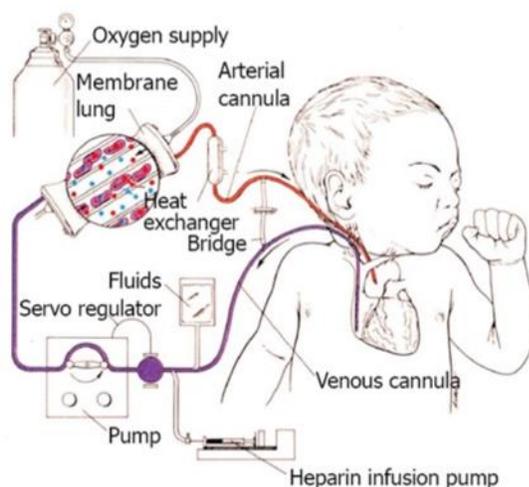
**Figure 1. Example of extracorporeal membrane oxygenation (ECMO) in an infant patient, which is used as a heart-lung bypass system outside the body. (12)**

as a form a rescue therapy, and has maintained mortality rates between 40-50% over the past several decades. A diagram detailing the setup of ECMO treatment is shown in Figure 1. The technology provides benefit over not providing any surgical intervention, but it is not a long-term solution. ECMO has led to numerous complications, including bleeding, blood clotting, infection, and inadequate oxygen delivery to the body. (12) Based on these complications and the high mortality rate, other mechanical support options have been explored for pediatric patients.

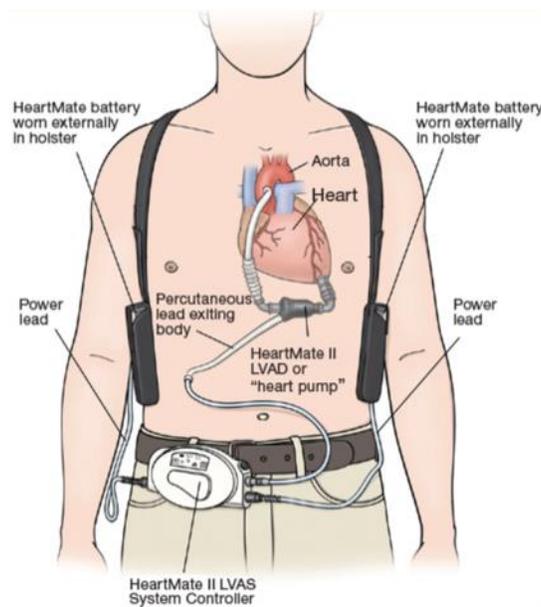
**Figure 2. Example of the HeartMate II in an adult patient, shown with an external battery connecting to the heart pump via a percutaneous lead. (11)**

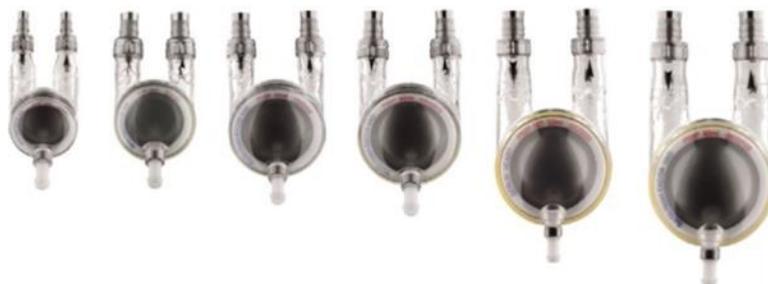
**Figure 3. Various sizes of the Berlin Heart EXCOR VAD, which are used to accommodate different sized children. (15)**

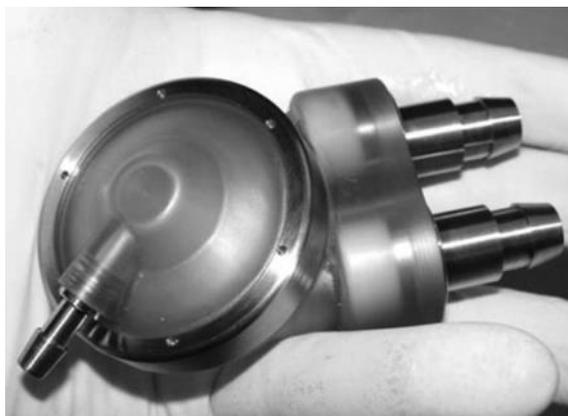
**Figure 4. Photograph of the Penn State Infant VAD, designed at the Penn State Hershey College of Medicine. (20)**

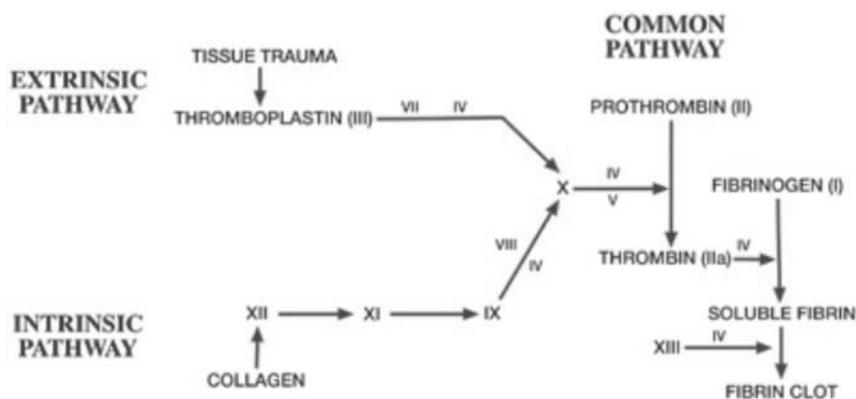
**Figure 5. Diagram of the factors released through different pathways of the coagulation cascade. (25)**

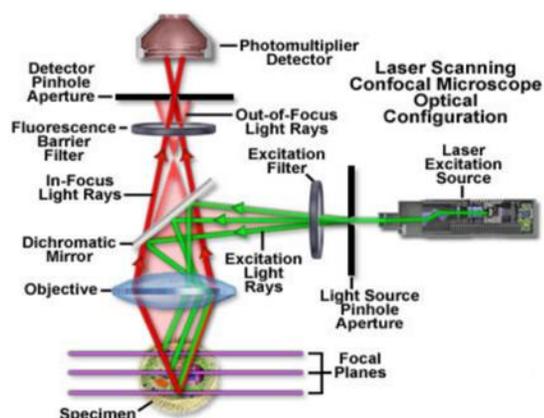
**Figure 6. Diagram of the light path through a specimen for images captured by confocal microscopy. (35)**

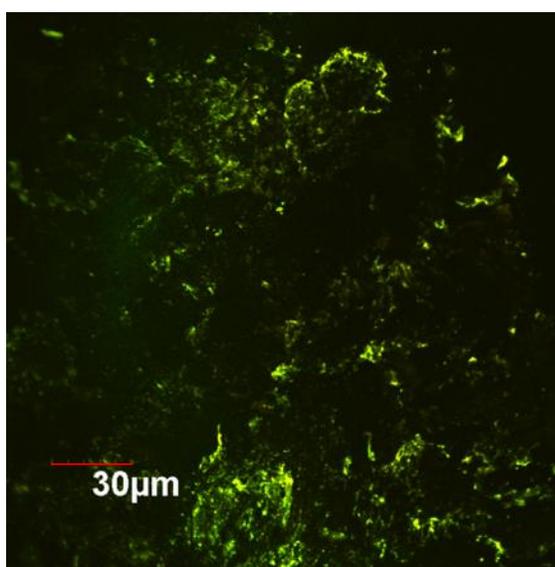
**Figure 7. Sample confocal microscopy image taken of a biological deposit on the surface of Penn State PVAD Sac 223.**

wavelengths, in comparison to widefield microscopes that offer a full range of wavelengths. The high-intensity laser emission can also be damaging to living cells and tissues. (35) A diagram of the light path is shown in Figure 6. A sample image taken from confocal microscopy during this study is shown in Figure 7.

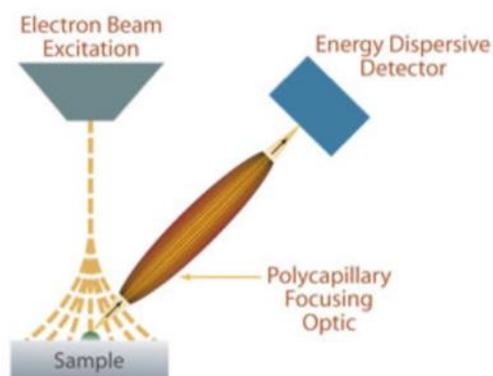
Figure 8. Diagram of the electron beam, sample, and energy detection that generates images by environmental scanning electron microscopy. (36)

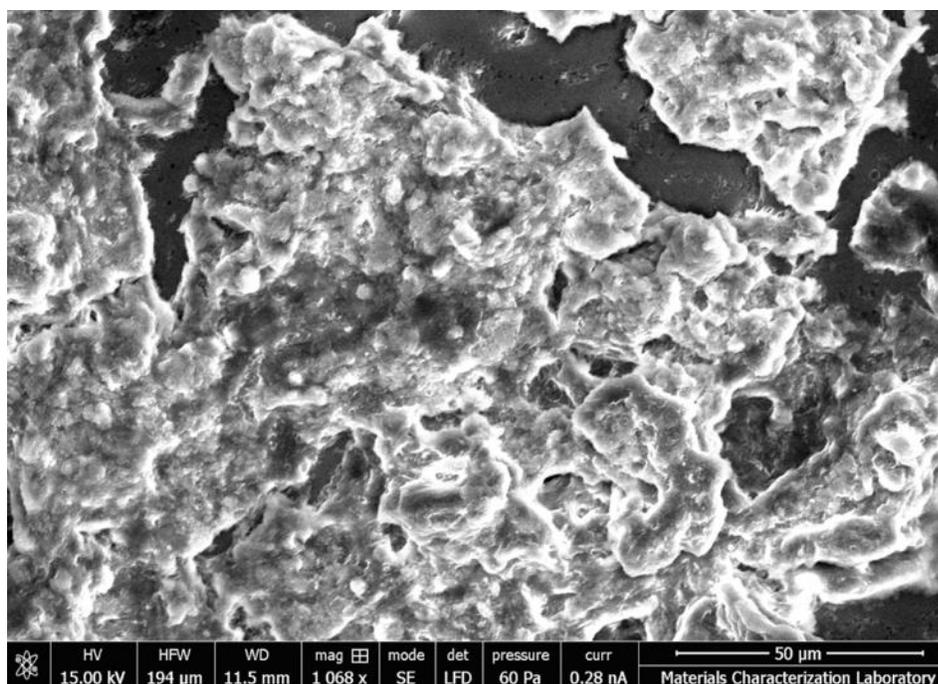
Figure 9. Sample environmental scanning electron microscopy image taken of a biological deposit on the surface of Penn State PVAD Sac 183.

The main advantage of this technique is that wet and insulating samples can be imaged without preparation by sputter coating. Specimens can be destroyed by the preparation methods required for conventional SEM, so ESEM offers a useful alternative for capturing images of a variety of biological materials. A disadvantage of ESEM is that the electron beam can undergo large-angle collisions, exciting regions outside the area of interest and reducing image contrast. While the resolution of ESEM images is not as high as conventional SEM, quality images are still possible because the water vapor in the chamber hydrates the sample and dissipates the build-up of charge generated by the electron beam. (37) A sample image taken from ESEM during this study is shown in Figure 9.

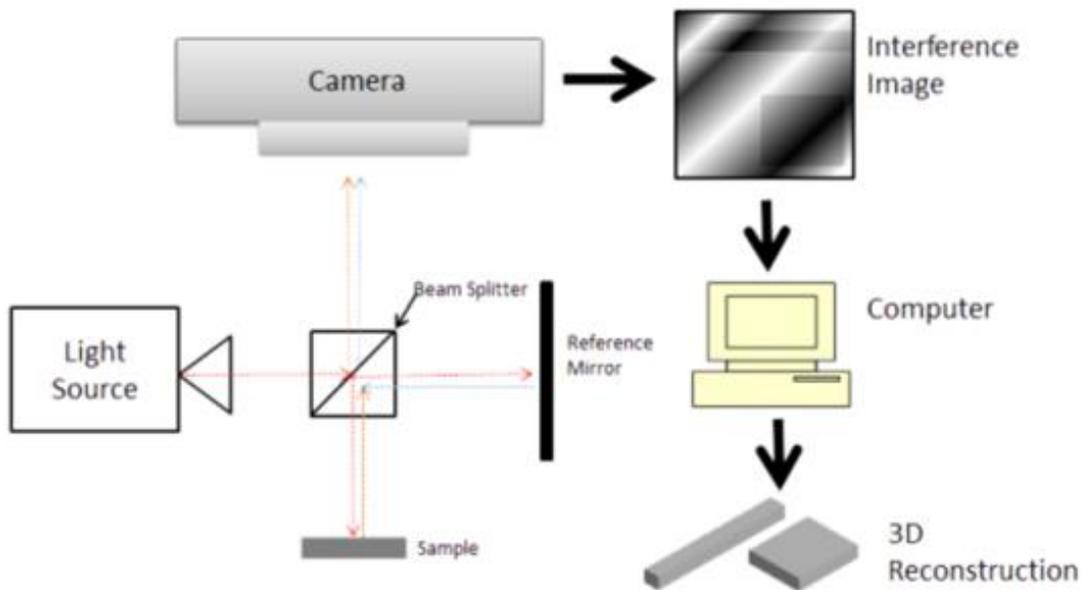
**Figure 10. Diagram of the light path through a specimen for images captured by optical profilometry. (38)**

Optical profilometry is used to obtain data about the topography of a surface without contacting the sample. This imaging technique can be used to measure roughness, step height, shape, and thickness of surfaces. When light is emitted from the source, the beam is split into two parts. One part of the beam is passed through the test material, and the other part of the beam is reflected on a mirror. The divided beams are recombined and passed to the camera, which processes data regarding the topography of the surface. (39) A schematic of this process is shown in Figure 10. (38)

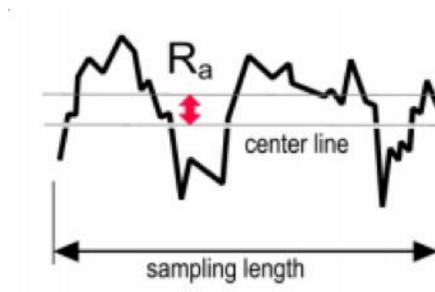
**Figure 11. Graph of the roughness average calculated along the sampling length of a material. (40)**

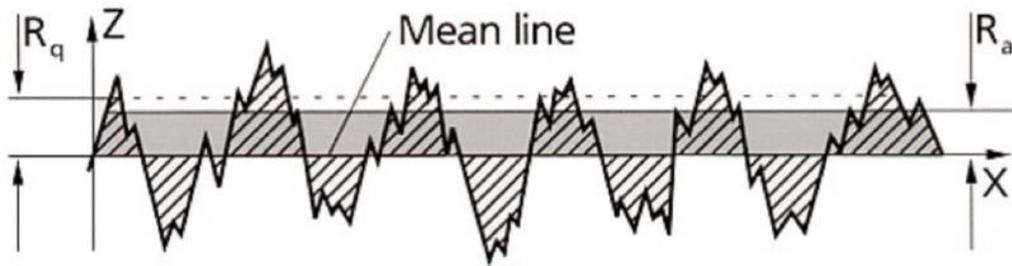
**Figure 12. Comparison of the roughness average (Ra) and the root-mean-square roughness (Rq). (40)**

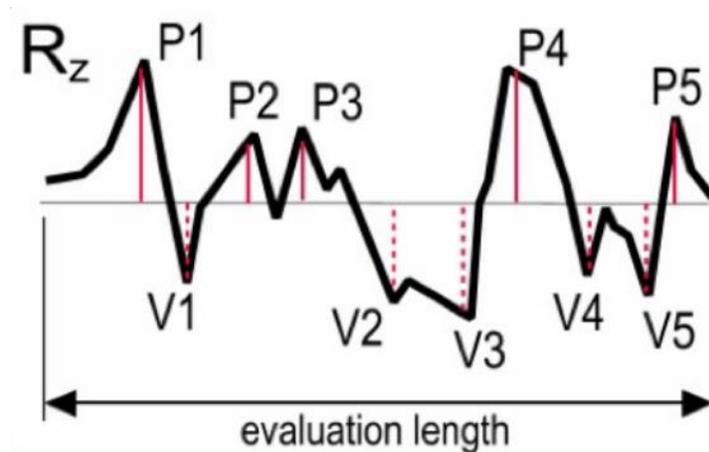
**Figure 13. Graph of the ten-point-height calculated along the evaluation length of a material. (40)**

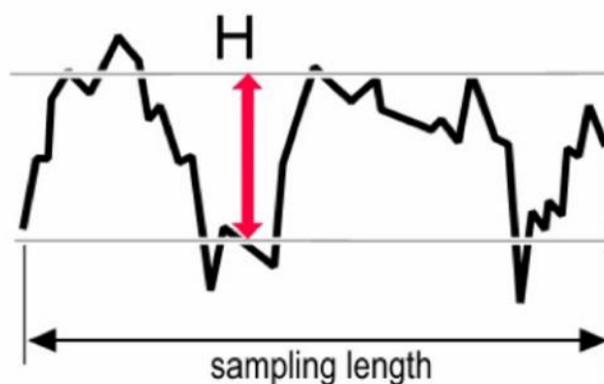
**Figure 14. Graph of the Swedish height calculated along the sampling length of a material. (40)**

The Swedish height (H) gives the roughness average of the middle 90% of the data. This parameter is less sensitive to the peaks and valleys. A graphical representation of the Swedish height is given in Figure 14, showing 5% of the data above the upper reference line and 5% of the data below the lower reference line. (40)

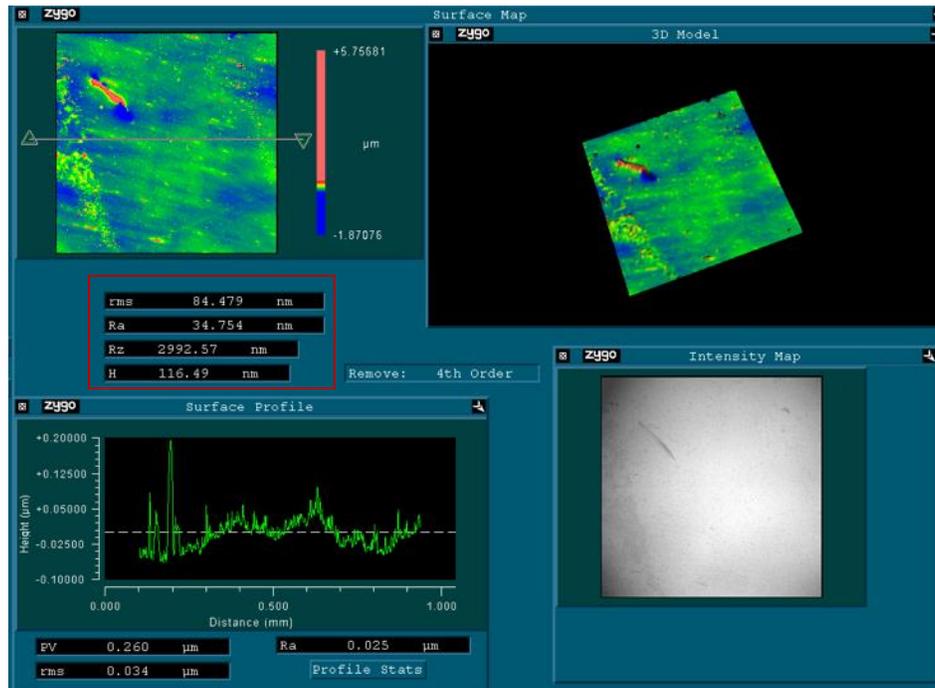
**Figure 15. Calculation of surface roughness parameters (Rq [shown in this software as rms], Ra, Rz, and H) using MetroPro using data collected from a surface of a Penn State PVAD blood sac. Surface roughness parameters are highlighted in red.**

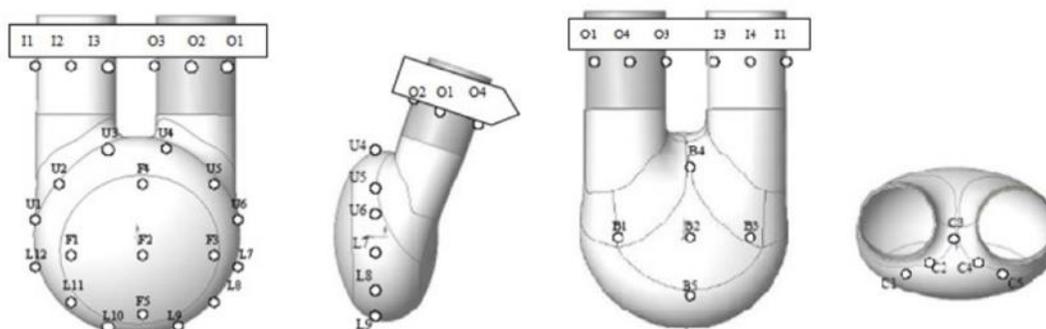
**Figure 16. Schematic of the locations on the blood sac. This diagram is used to describe the locations of deposits and for regions of sampling.**

documented according to the schematic in Figure 16. Following documentation, the saline was replaced with 1% PFA and the inlet and outlet of the sac were clamped. After fixing for 1 hour, the PFA was rinsed out by pouring 1 L of saline through the inlet. The saline was replaced with PBS and the inlet and outlet were re-clamped. The blood sacs were stored individually in 8 oz. plastic containers in a refrigerator at 4°C until transportation to University Park.

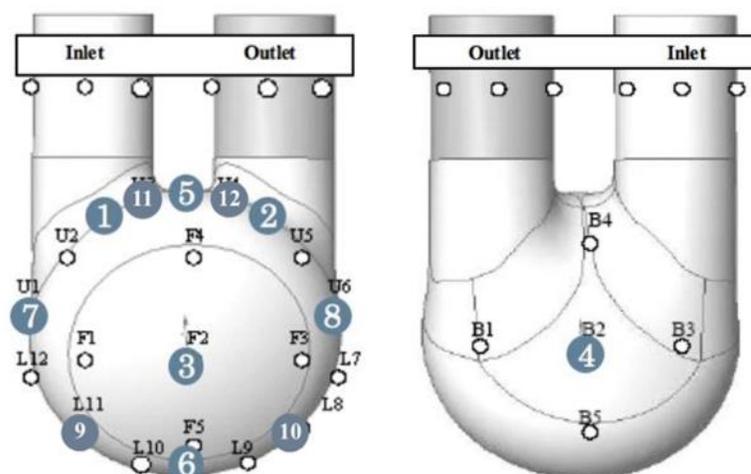
Figure 17. Sampling regions of blood contacting sac. Left: diaphragm side facing forward. Right: stationary side facing forward.

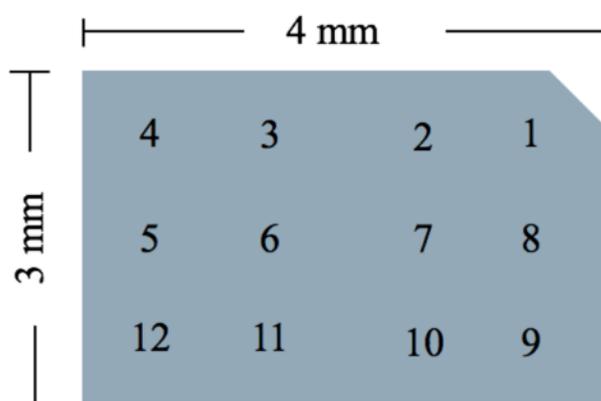
Figure 18. Patterned method for imaging samples. Twelve regions are imaged for each sample. (35)

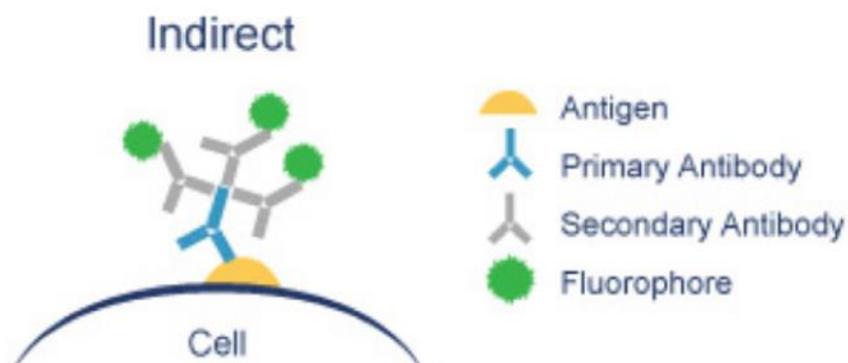
**Figure 19. Indirect immunofluorescent labeling method used for labeling platelets. (42)**

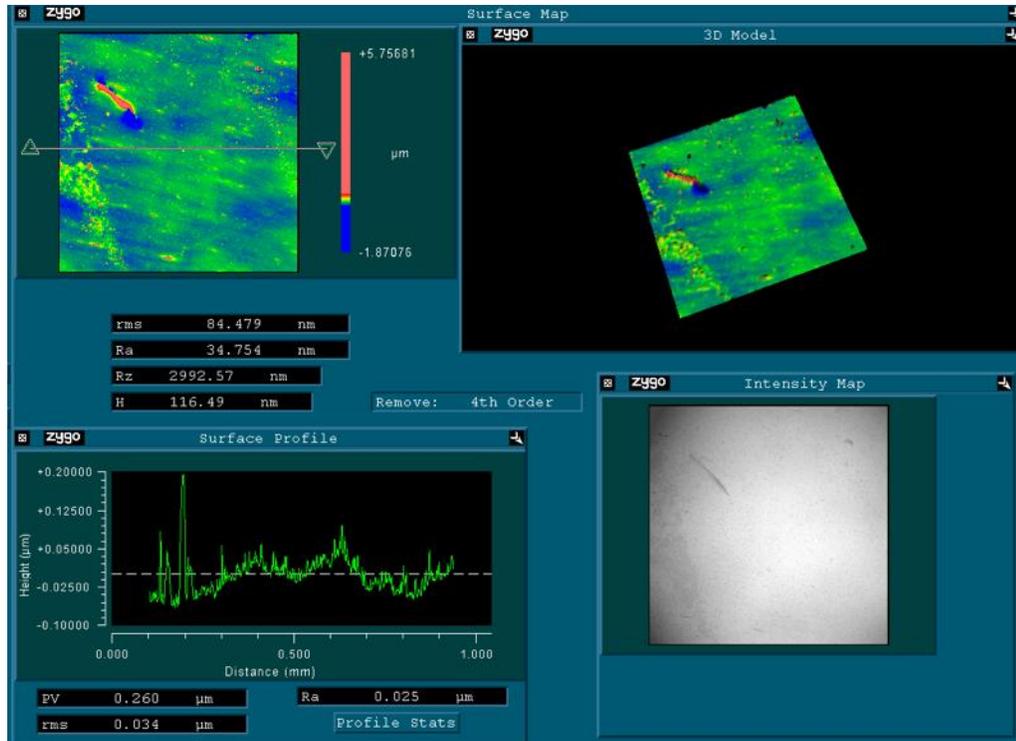
**Figure 20.** The MetroPro interface shows a piece of debris with elevated topography on the 3D model. This is an example of an area that would be masked and removed from surface analysis.

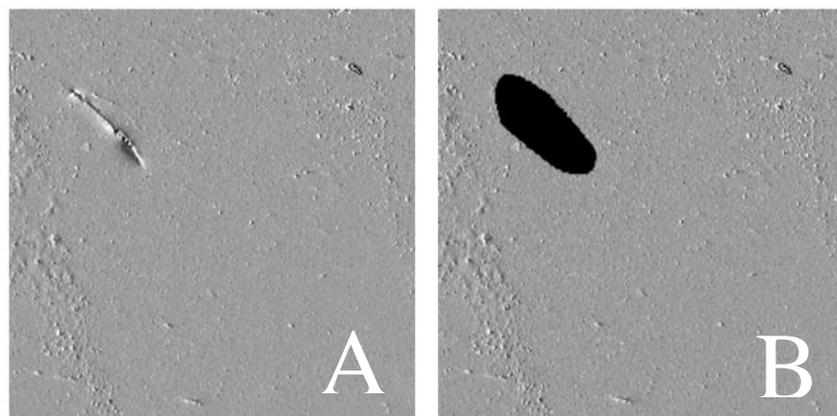
**Figure 21. An example of a profilometry image from Sac 249, Sample 4, Region 3 (A) without masking and (B) with masking applied.**

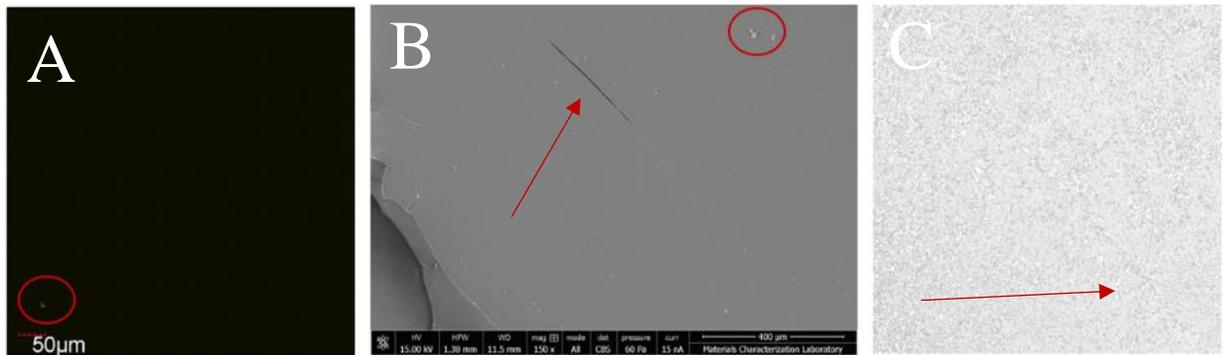
**Figure 22. Correlation of (A) confocal, (B) ESEM, and (C) profilometry images on the inlet of Sac 170. There is a small microscopic deposit circled in red and a scratch shown by the arrows.**

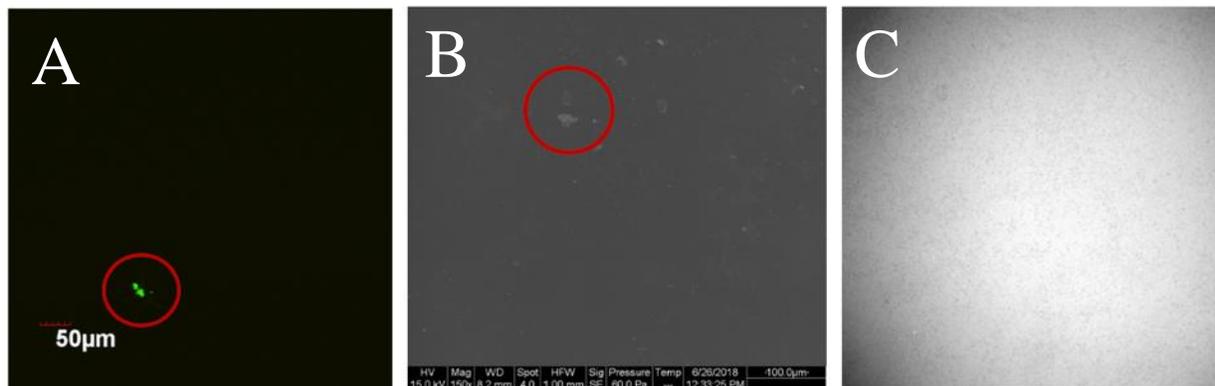
From Sac 172, there was a slightly larger green deposit found on region 7 of the inlet top sample, shown in Figure 23. This deposit was approximately 20  $\mu\text{m}$  in diameter. The profilometry image shows that the surface is relatively smooth.

**Figure 23. Correlation of (A) confocal, (B) ESEM, and (C) profilometry images on the inlet top of Sac 172. There is a small microscopic deposit circled in red.**

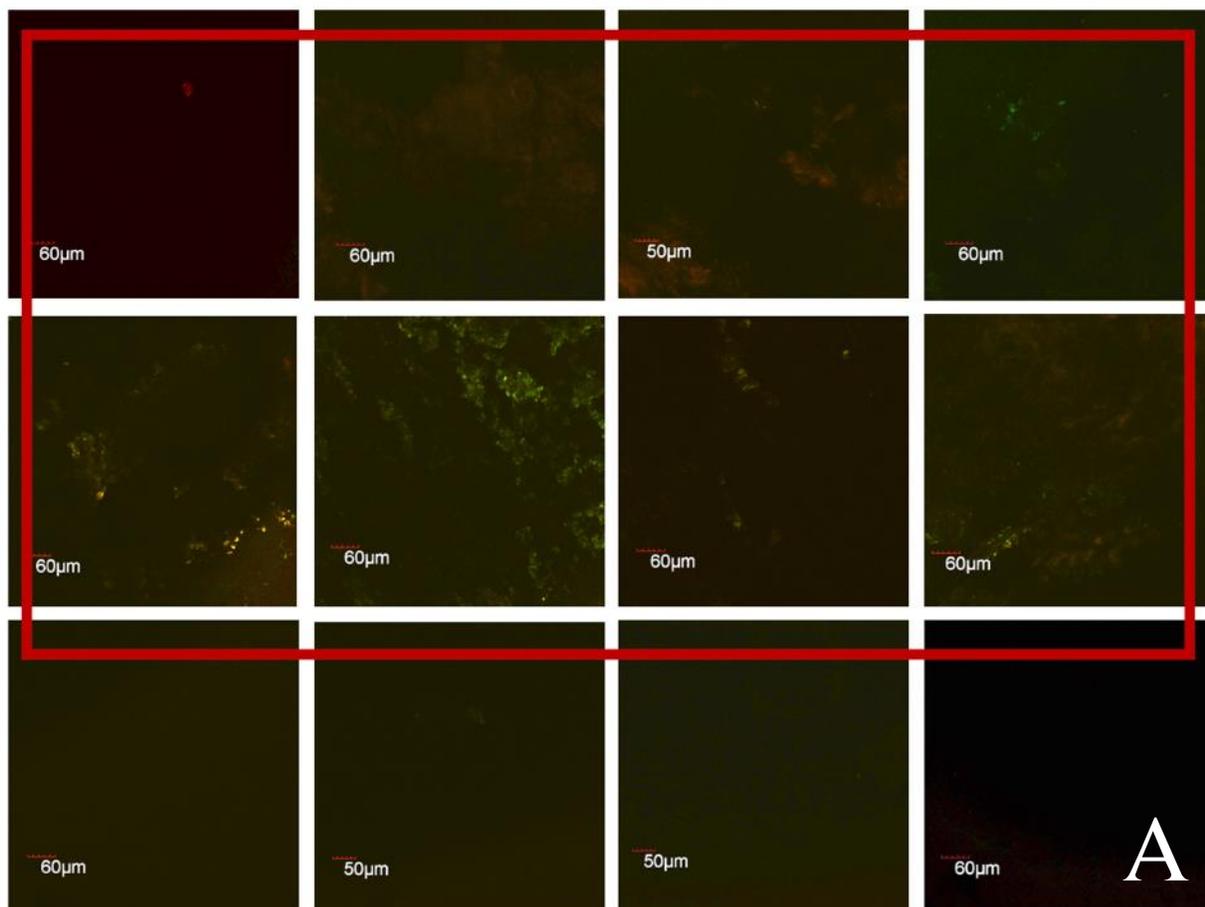
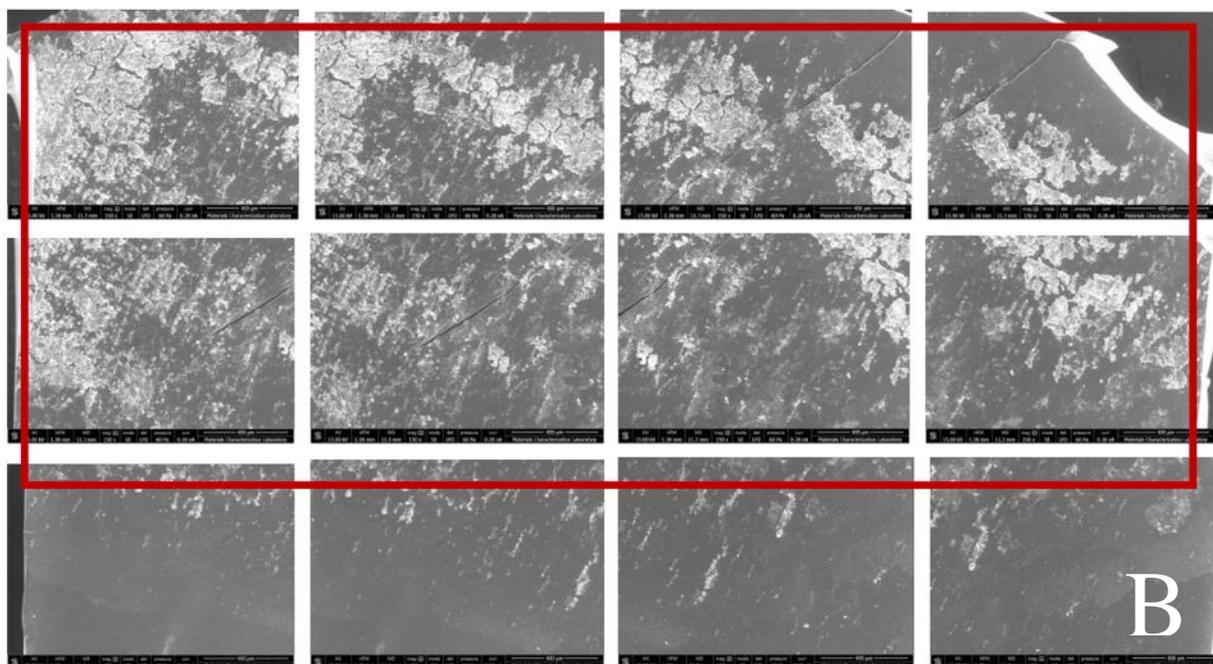
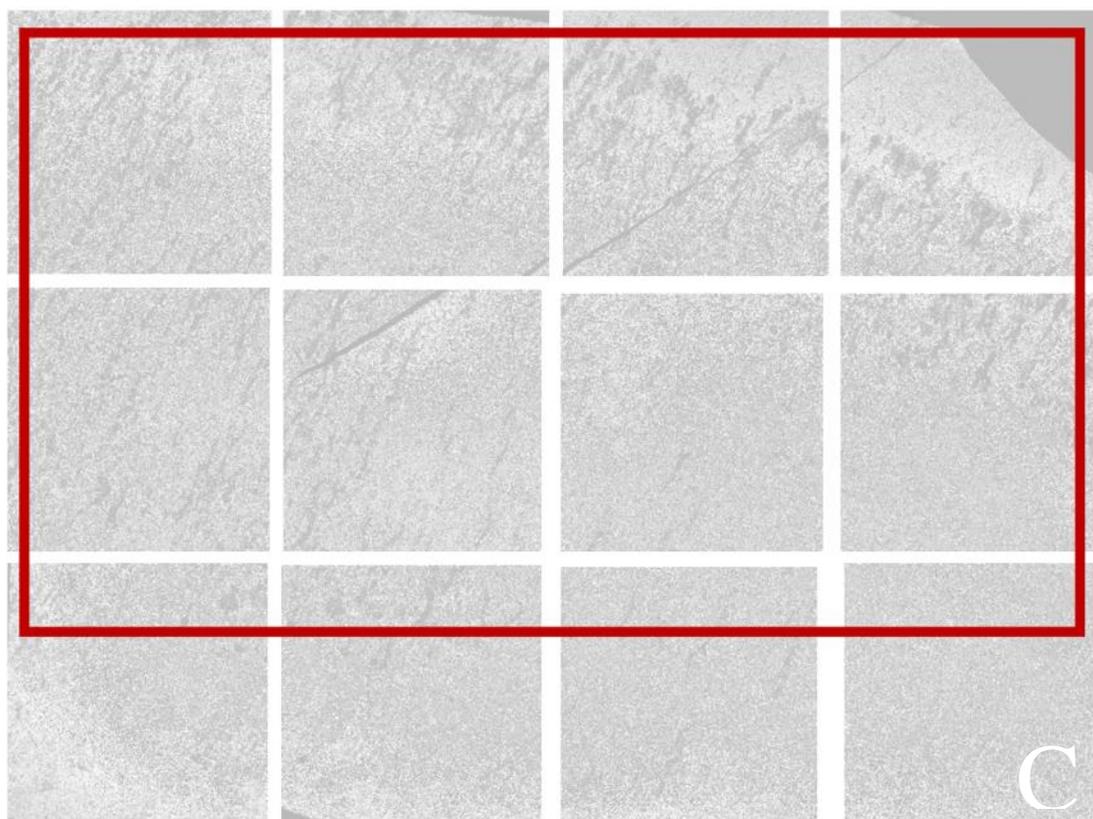
Sac 183 featured the most significant deposition that spanned across the entire sample at the outlet top, as presented in parts A, B, and C of Figure 24. The deposit covered a patch of approximately 4000 x 2000  $\mu\text{m}$ . The biologics were degraded twice but did not fully degrade. Remaining biologics were masked out of the data collection so that only the true surface of the material was analyzed for roughness.

**Figure 24. Correlation of (A) confocal, (B) ESEM, and (C) profilometry images on the outlet top of Sac 183. There is large macroscopic deposition shown within the red boxes. Topography shows some residual biologics.**

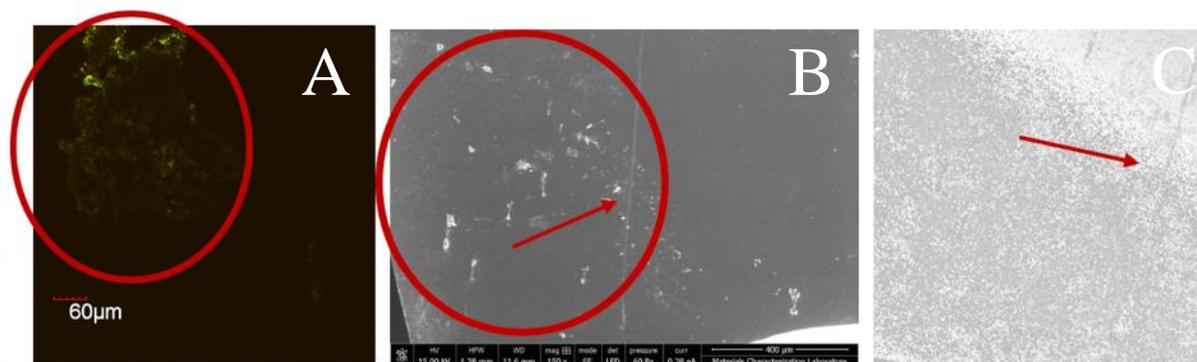
**Figure 25. Correlation of (A) confocal, (B) ESEM, and (C) profilometry of the inlet top of Sac 190. There is scatted deposition circled in red. The arrows point to a scratch on the surface.**

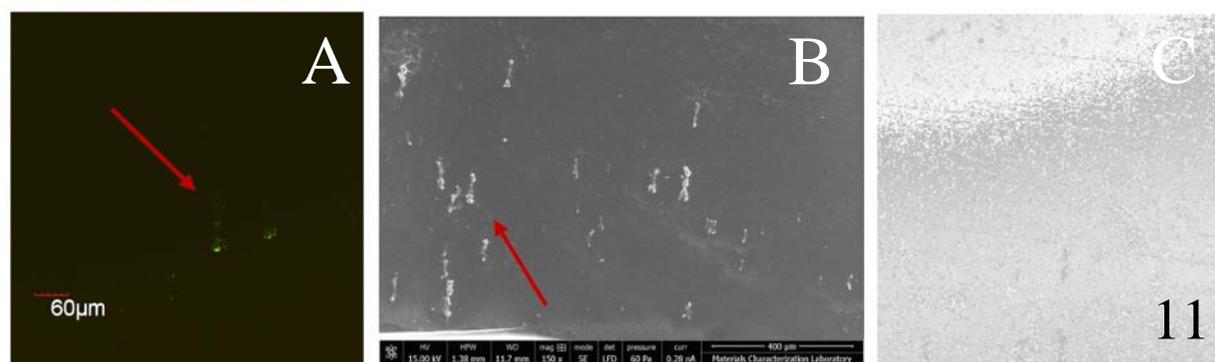
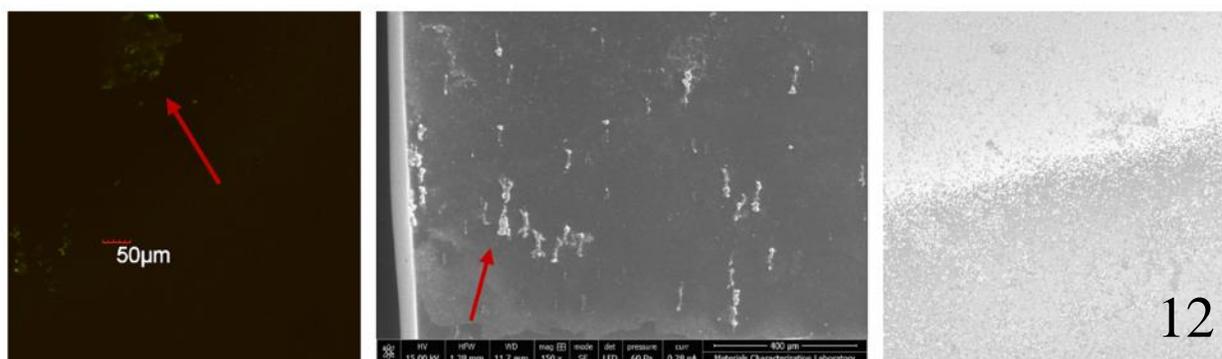
**Figure 26. Correlation of (A) confocal, (B) ESEM, and (C) profilometry of the outlet top of Sac 190. Scattered deposition is shown by the red arrows and spreads across regions 11 and 12.**

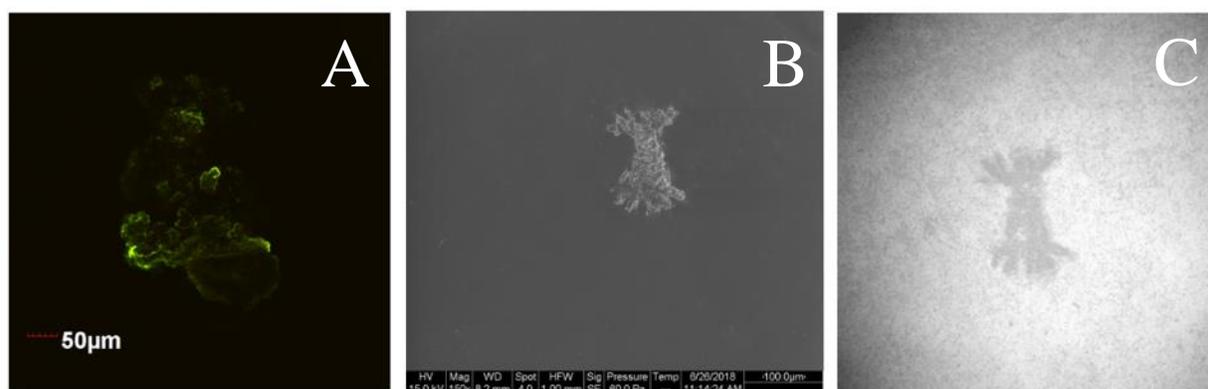
Sac 223 showed deposits at the inlet bottom (Figure 27) and the outlet top (Figure 29). The macroscopic deposit on the inlet bottom had a diameter of approximately 150  $\mu\text{m}$ . The structure is clearly verified by ESEM. Significant biologics remained on the topography, even after the sample was degraded three times. The surface map of this deposit is shown in Figure 28. The 3D model shows that the topography is raised above the surface. The biologics were masked from the data collection. There was a very small, microscopic deposit found on the outlet top.

**Figure 27. Correlation of (A) confocal, (B) ESEM, and (C) profilometry on the inlet bottom of Sac 223. There is a large macroscopic deposit seen on the surface. The biologics were not fully degraded from the profilometry image.**

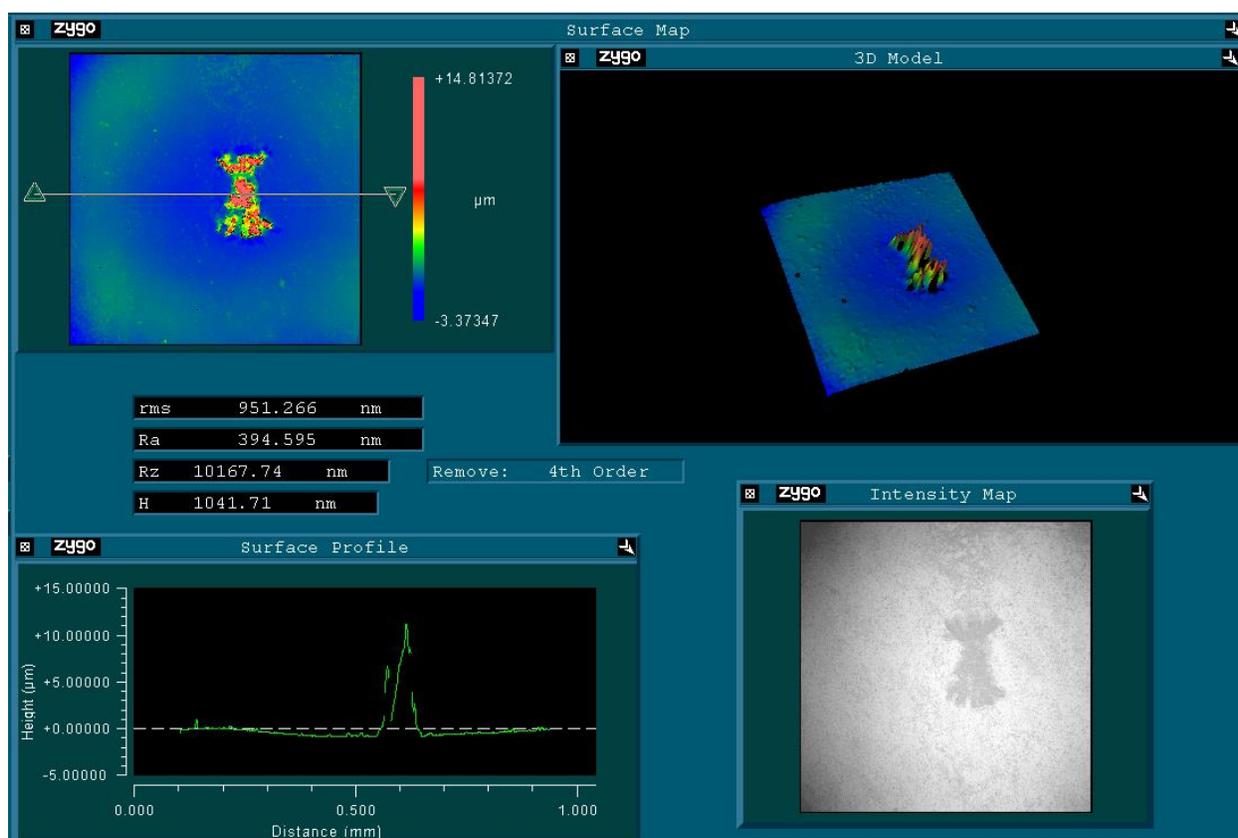
**Figure 28.** MetroPro analysis for region 5 of the inlet bottom on Sac 223. The 3D model and surface profile show the raised topography in the area of interest.

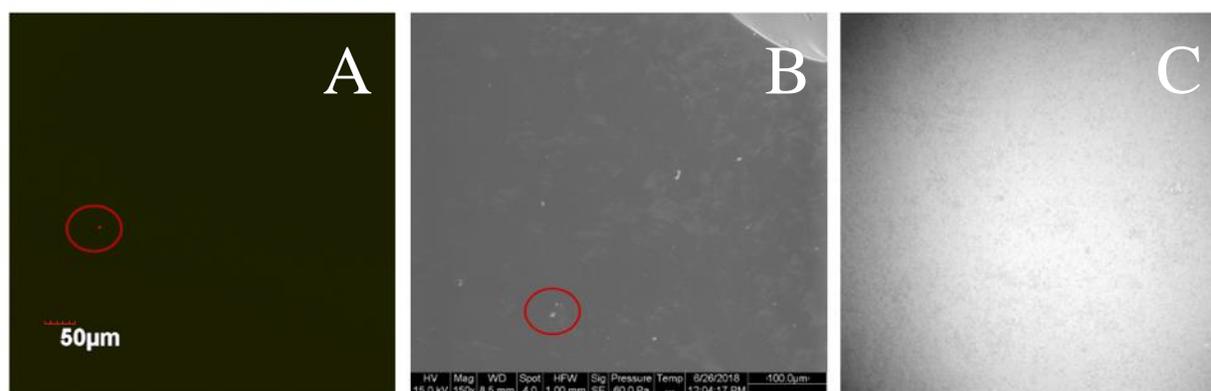
**Figure 29.** Correlation of (A) confocal, (B) ESEM, and (C) profilometry on the outlet top of Sac 223. There is a small, macroscopic deposit shown in the red circles.

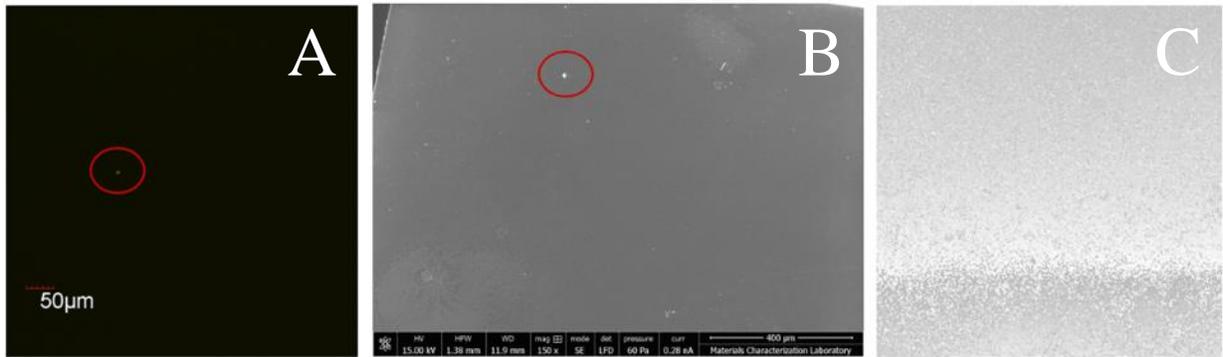
**Figure 30. Correlation of (A) confocal, (B) ESEM, and (C) profilometry on the outlet bottom of Sac 234. There was a small, microscopic deposit shown by the red circles.**

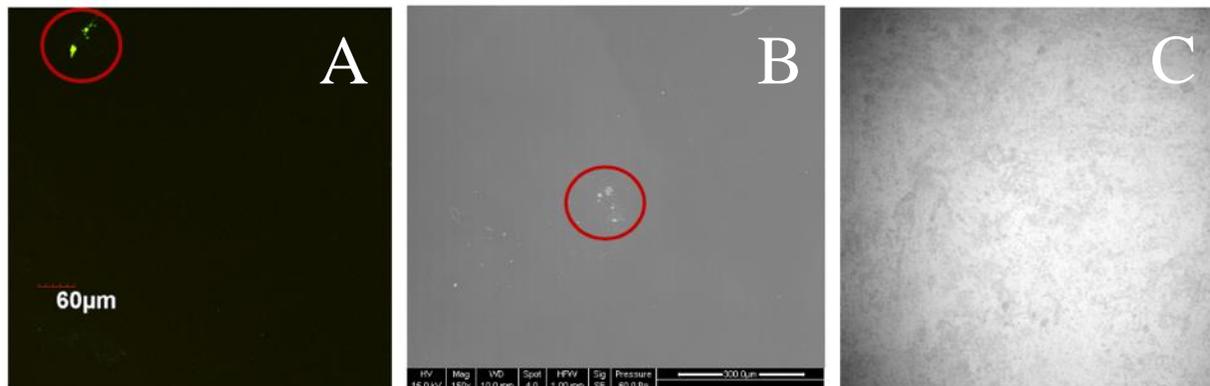
Figure 31. Correlation of (A) confocal, (B) ESEM, and (C) profilometry on the outlet of Sac 240. There is a microscopic deposit shown by the red circles.

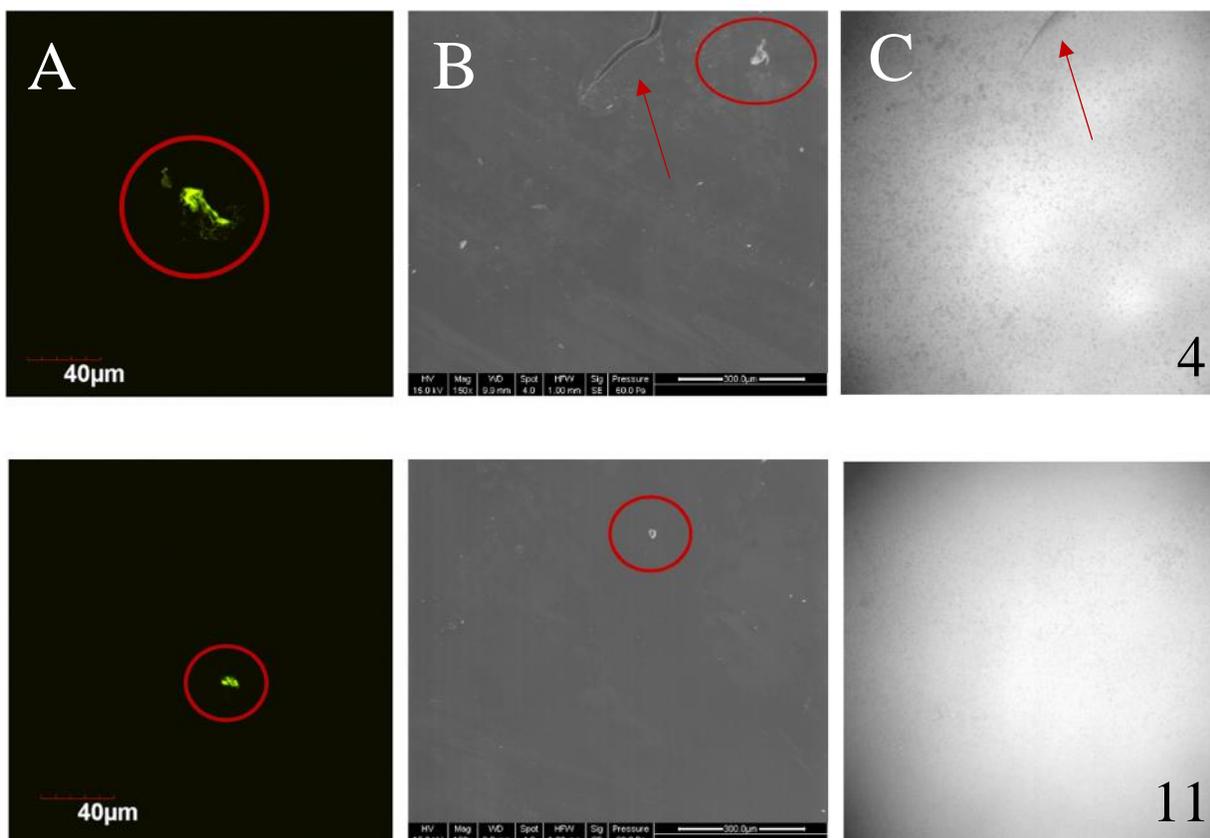
Figure 32. Correlation of (A) confocal, (B) ESEM, and (C) profilometry on the bottom of Sa 240. There is a moderate microscopic deposit on region 4 and a small microscopic

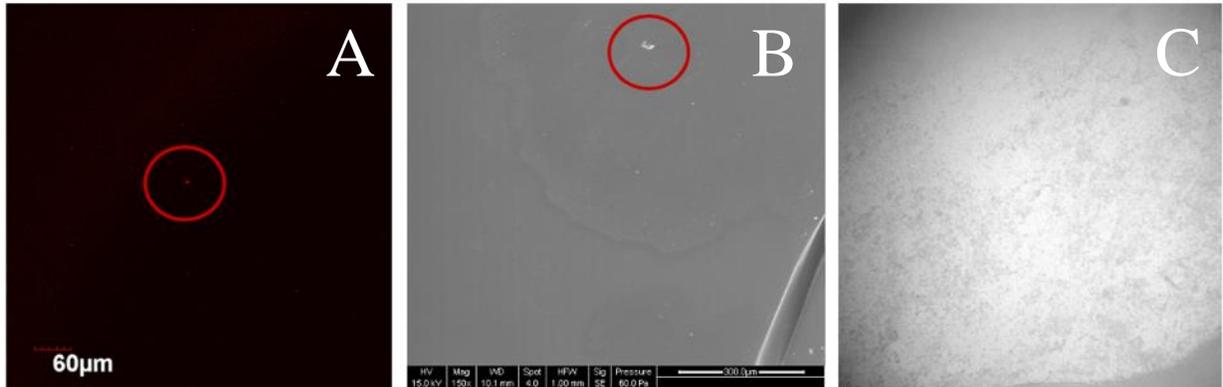
Figure 33. Correlation of (A) confocal, (B) ESEM, and (C) profilometry on the inlet top of Sac 240. There is a small microscopic deposit shown by the red circles.

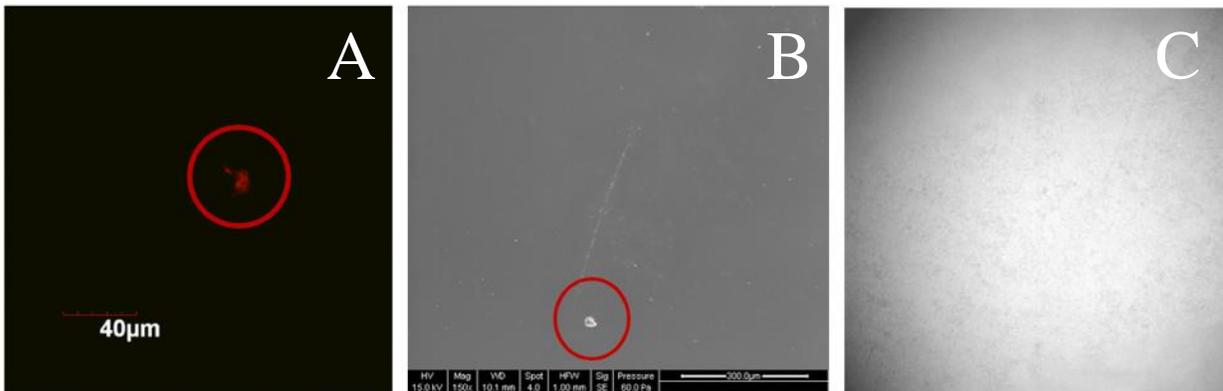
Figure 34. Correlation of (A) confocal, (B) ESEM, and (C) profilometry on the outlet top of Sac 240. There is a microscopic deposit shown by the red circles.

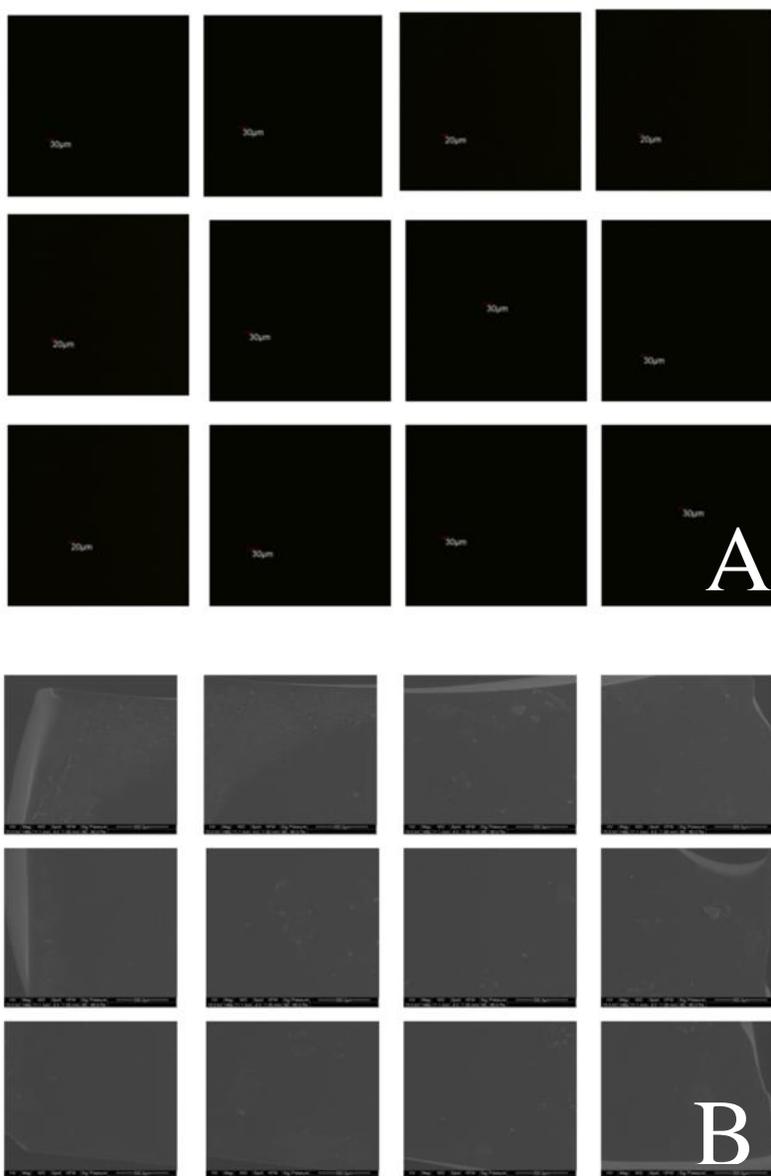
**Figure 35. Images taken by confocal (A) and ESEM (B) of the control sac. No fluorescence is noted.**

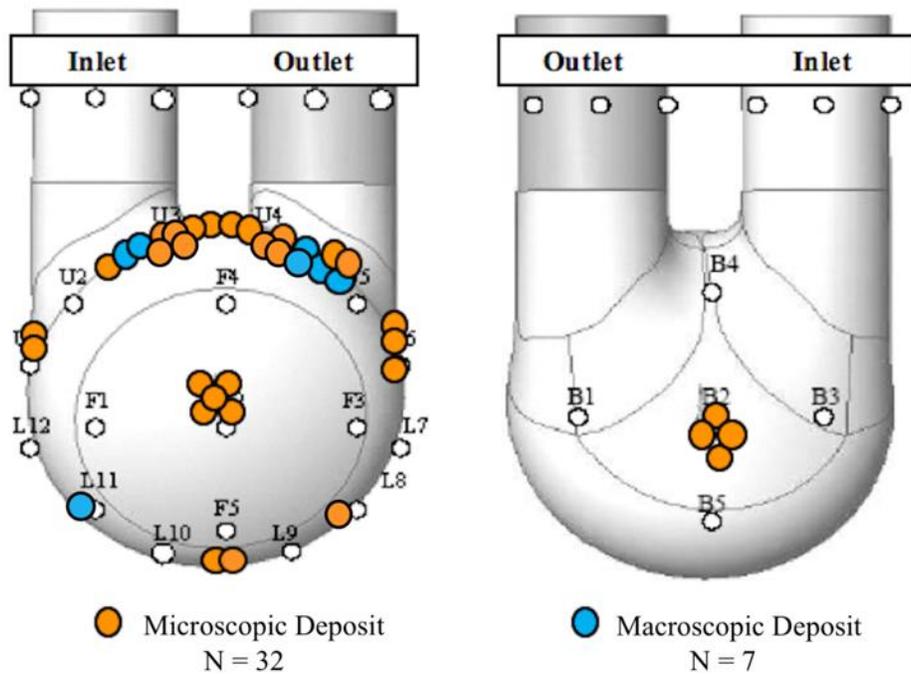
**Figure 36. Map of all deposits for the 13 sacs analyzed.**

After the 13 sac analyses were completed, the locations of the deposits were noted. Figure 36 provides a map of all deposits found over the 13 sacs. There were 7 macroscopic deposits and 32 microscopic deposits. Most of the deposits were located along the upper ridge near the inlet, top, or outlet.

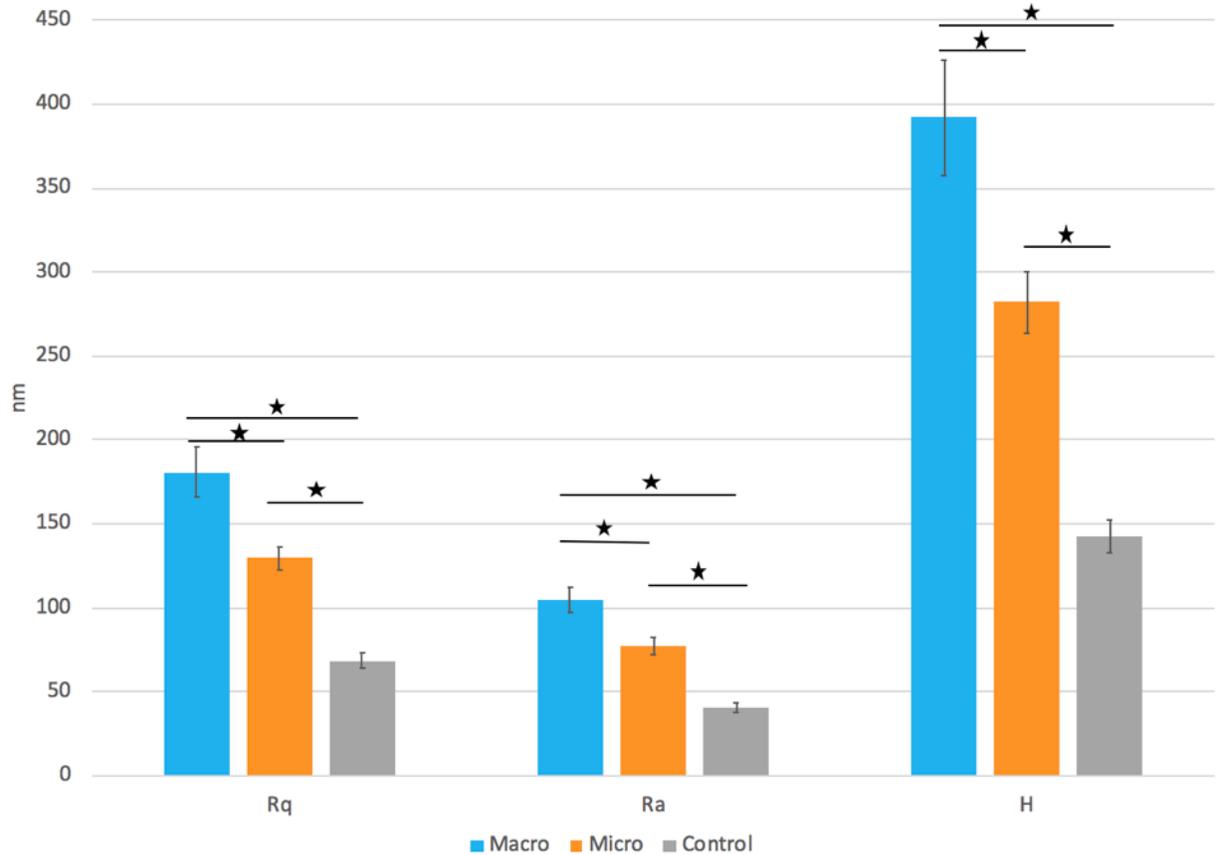
**Figure 37. Comparing average Rq, Ra, and H values between macroscopic and microscopic deposits and a control sac. Error bars indicate the standard error of the mean.**
