THE PENNSYLVANIA STATE UNIVERSITY  
SCHREYER HONORS COLLEGE

DEPARTMENT OF BIOMEDICAL ENGINEERING

STUDYING THROMBOSIS AND SURFACE ROUGHNESS IN THE PENN STATE  
PEDIATRIC VENTRICULAR ASSIST DEVICE

CECILIA A. RICHARDSEN  
SPRING 2019

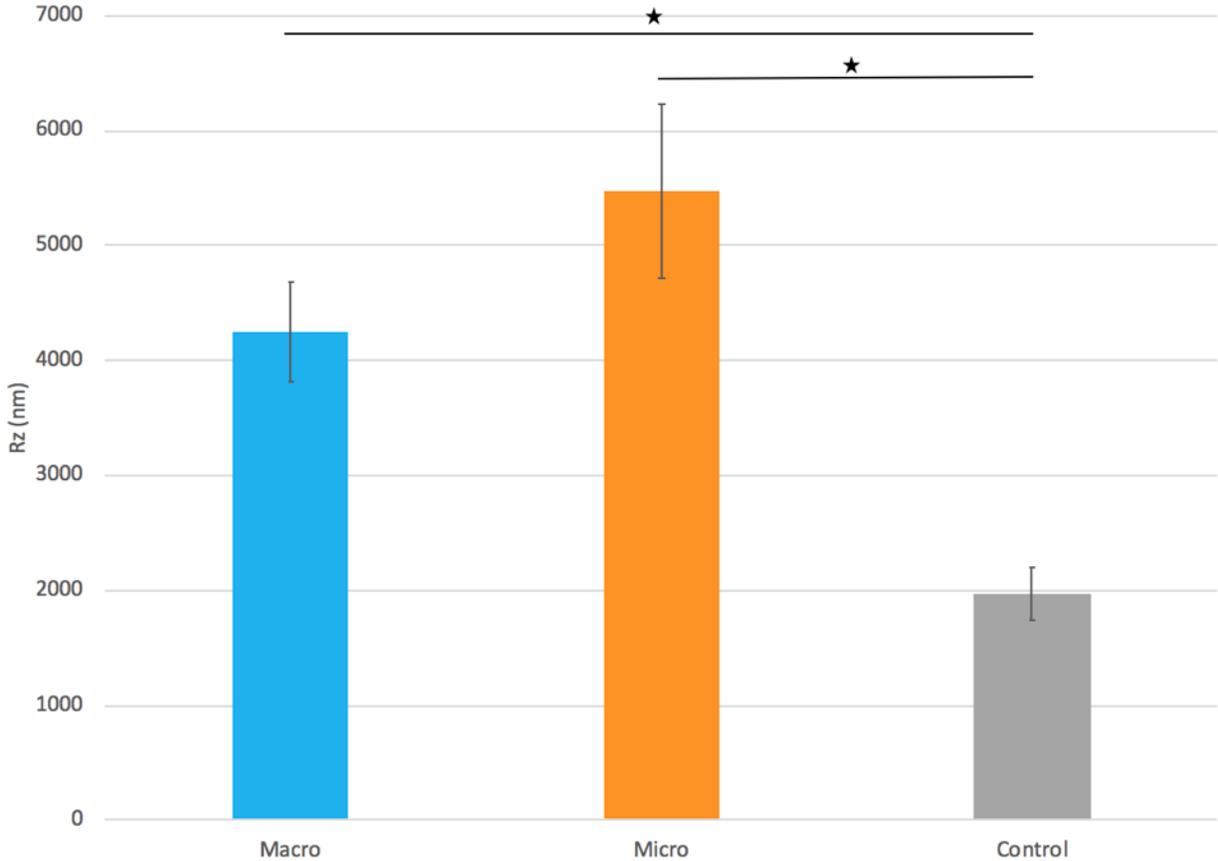
**Figure 38. Comparing average Rz values between macroscopic and microscopic deposits and a control sac. Error bars indicate the standard error of the mean.**

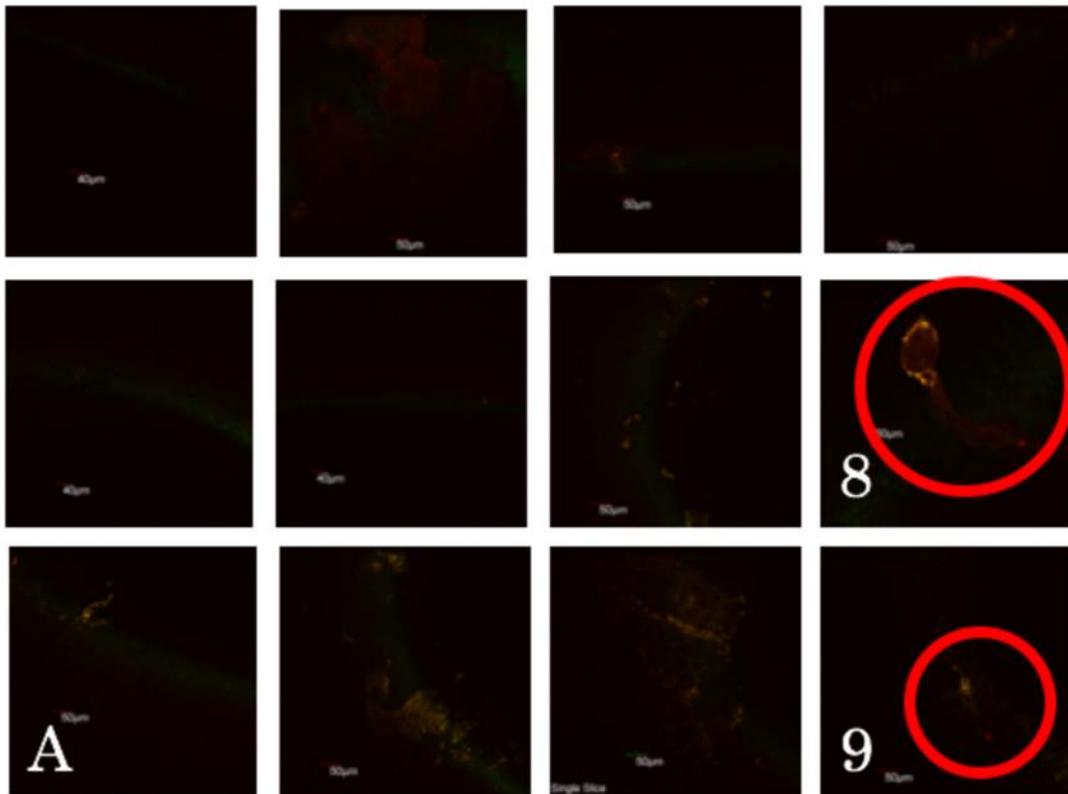
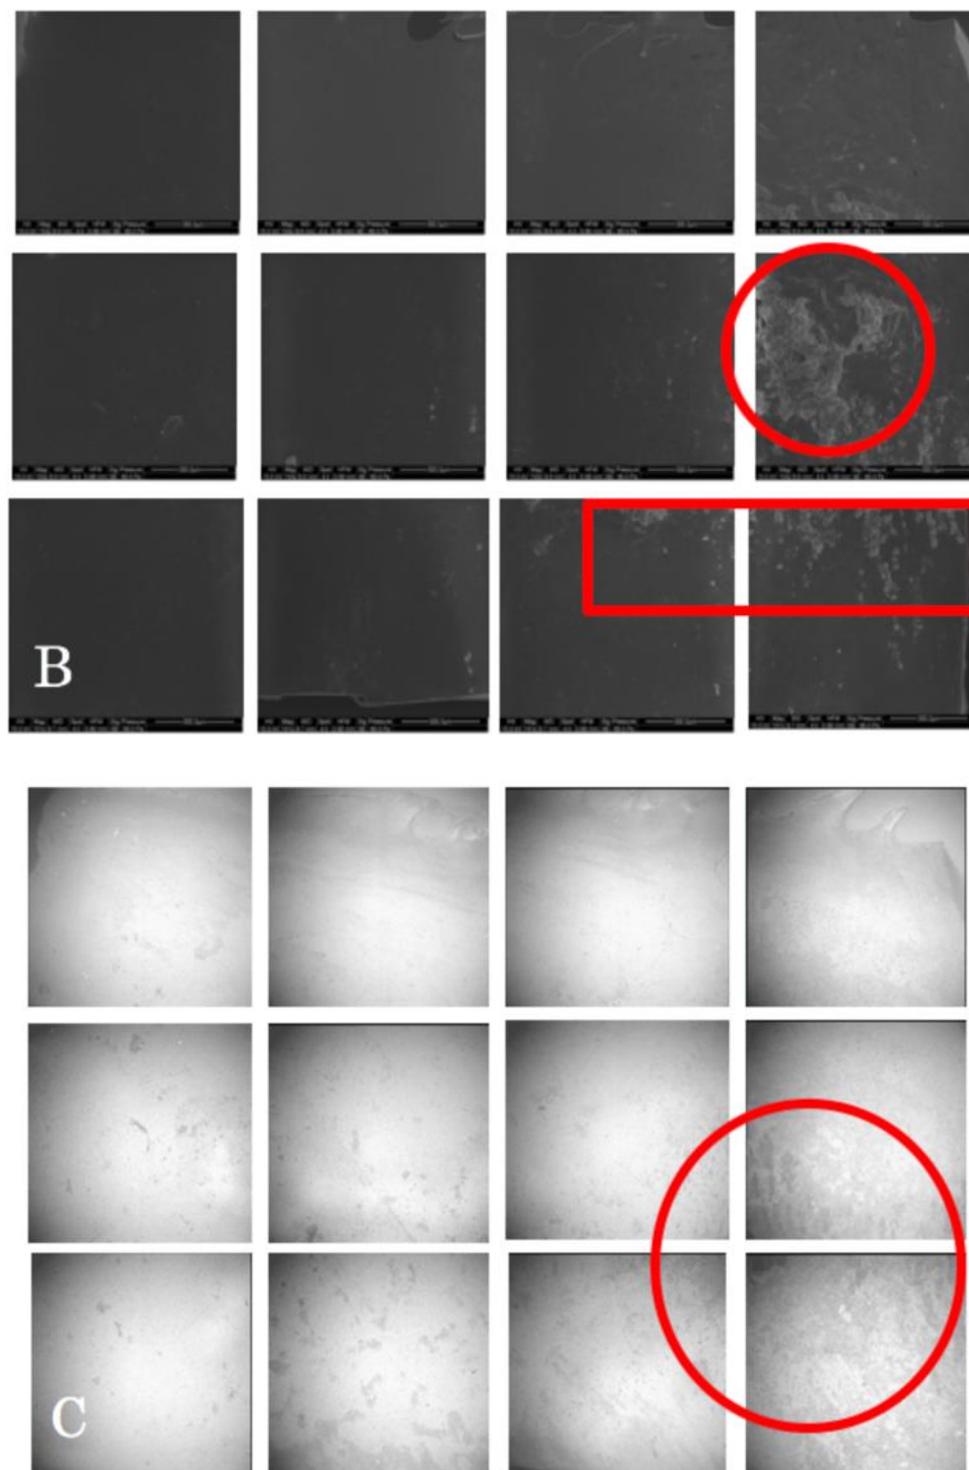
**Figure 39. A small, macroscopic deposit found with (A) confocal, was confirmed with (B) ESEM at the inlet of Sac 170. The (C) profilometry showed scuffing. (34)**

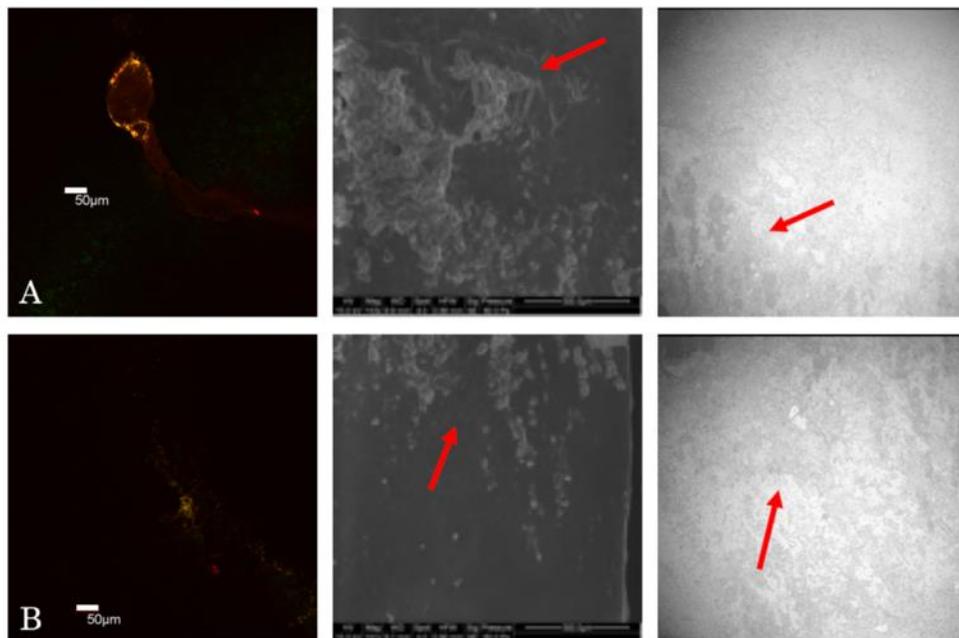
Figure 40. A closer examination of (A) Region 8 and (B) Region 9 of the inlet of Sac 170.  
(34)

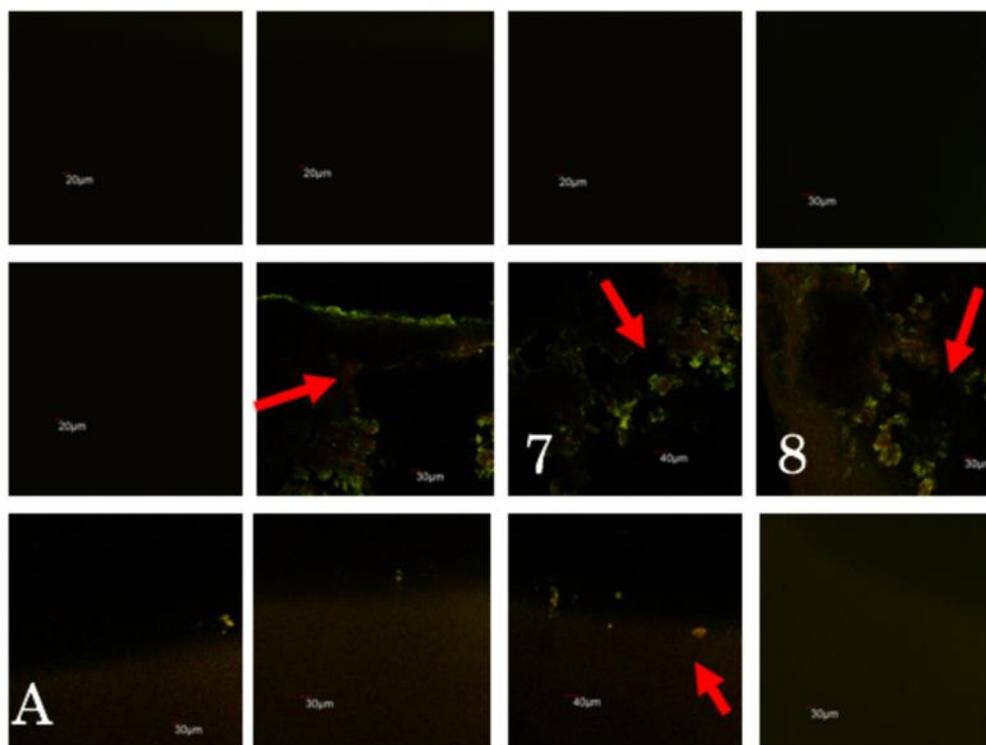
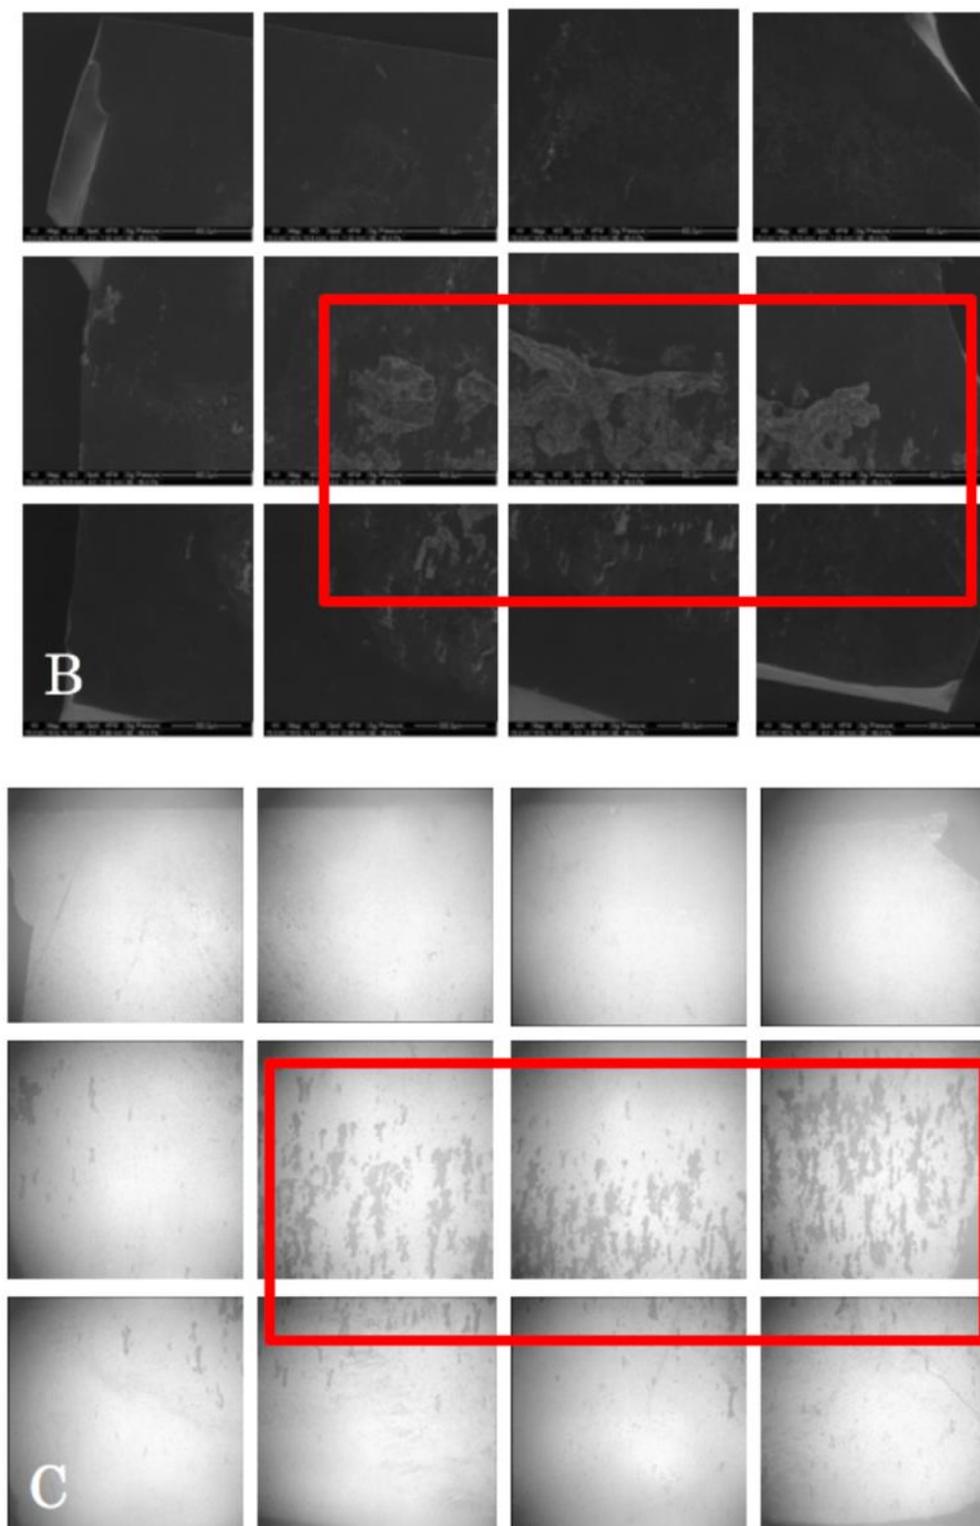
**Figure 41. A large, macroscopic deposit found with (A) confocal and confirmed with (B) ESEM. Residual biologics are seen on (C) the profilometry of the inlet of Sac 183. (34)**

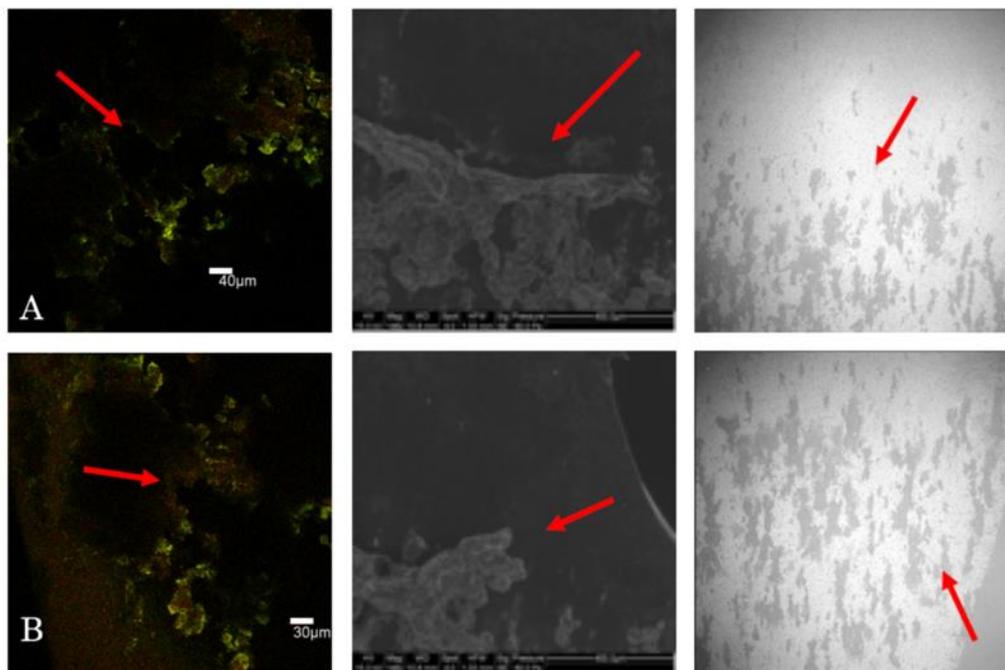
Figure 42. A closer examination of (A) Region 7 and (B) Region 8 of the inlet of Sac 183.  
(34)

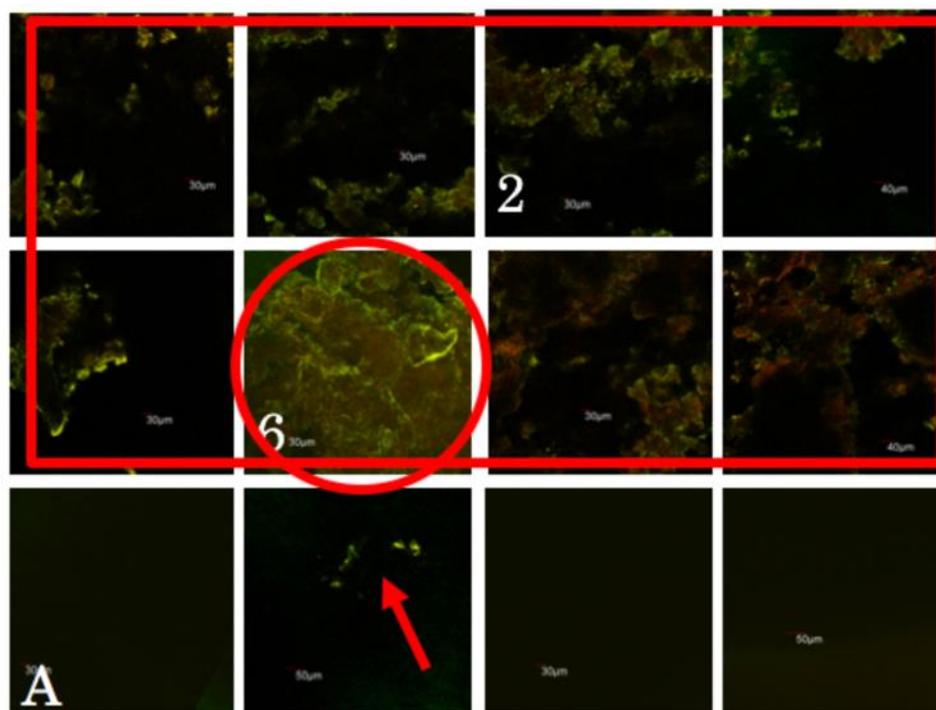
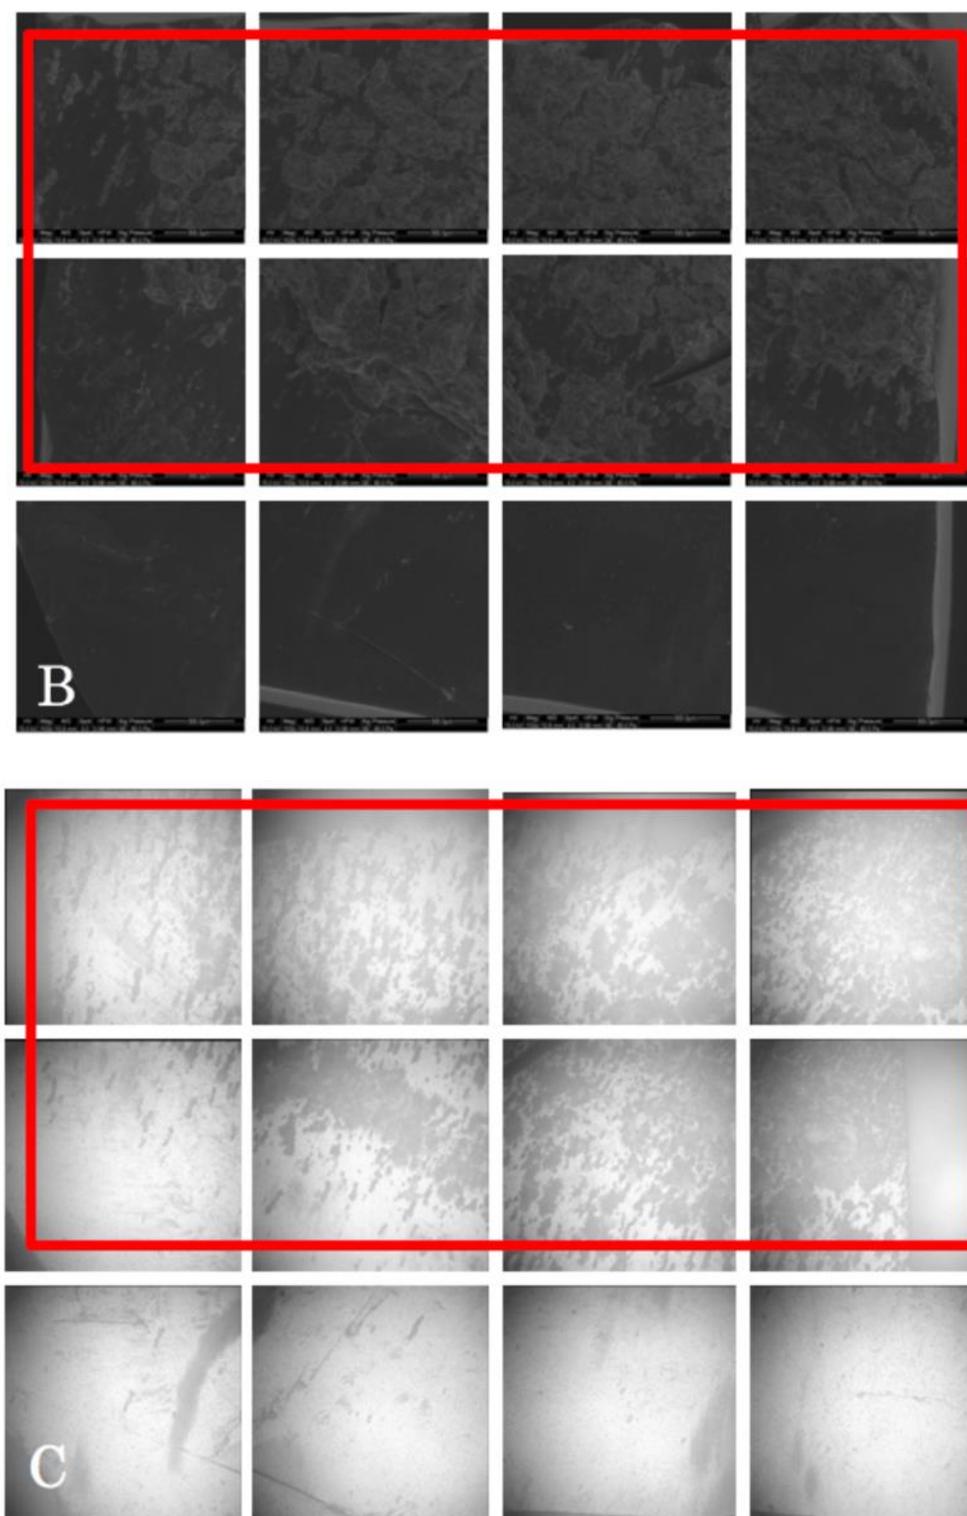
**Figure 43. A very large macroscopic deposit seen by (A) confocal and (B) ESEM on the outlet of Sac 183. The (C) profilometry shows residual biologics on the surface. (34)**

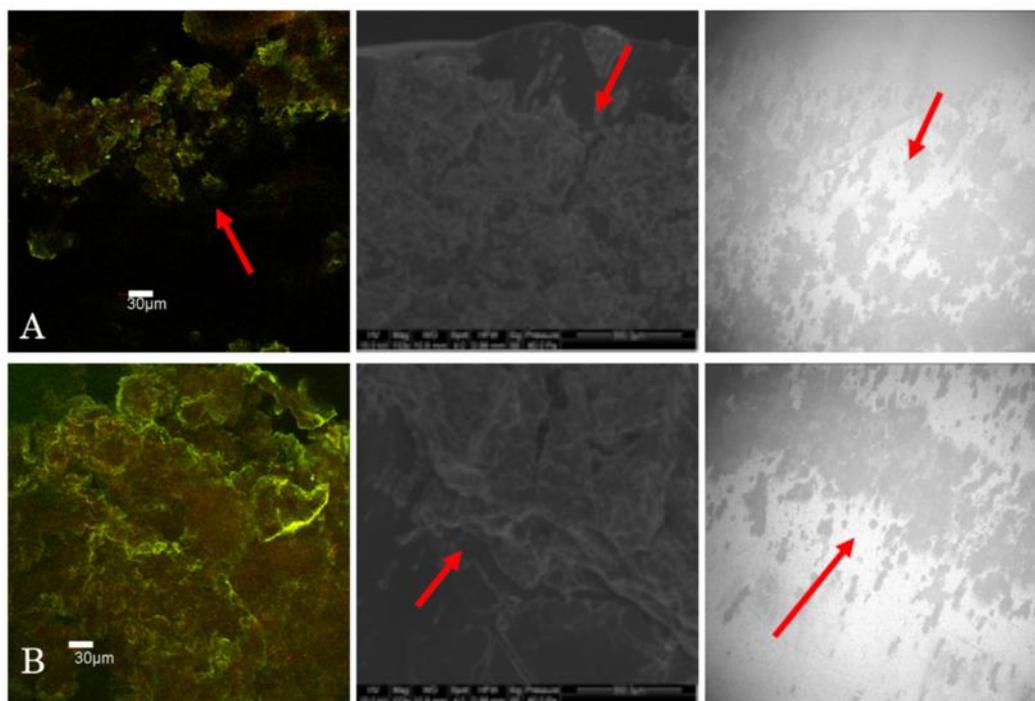
Figure 44. A closer examination of (A) Region 2 and (B) Region 6 of the outlet of Sac 183.  
(34)

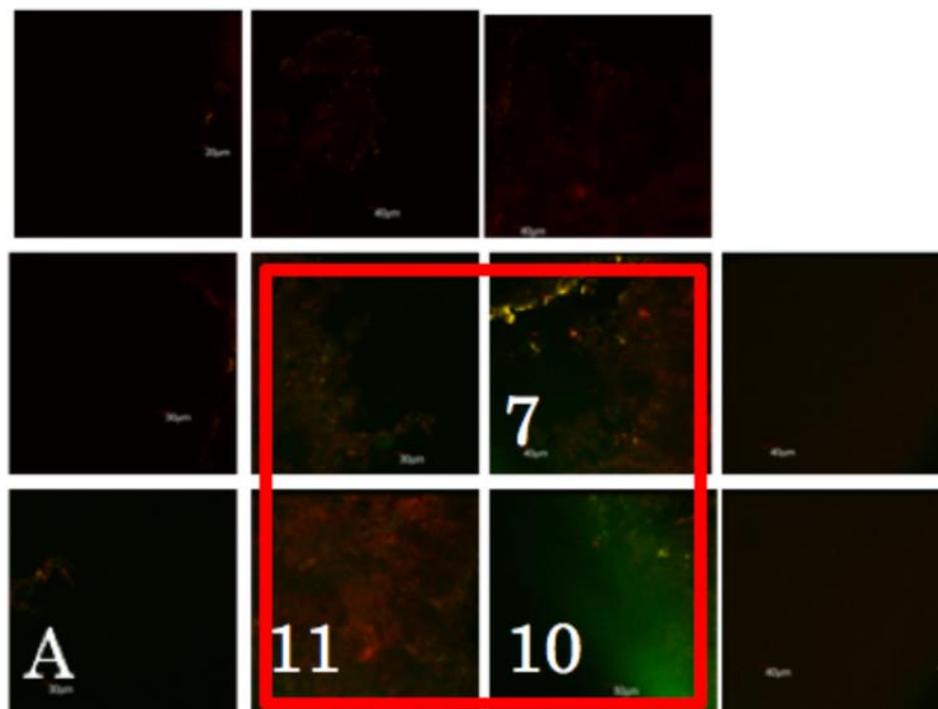
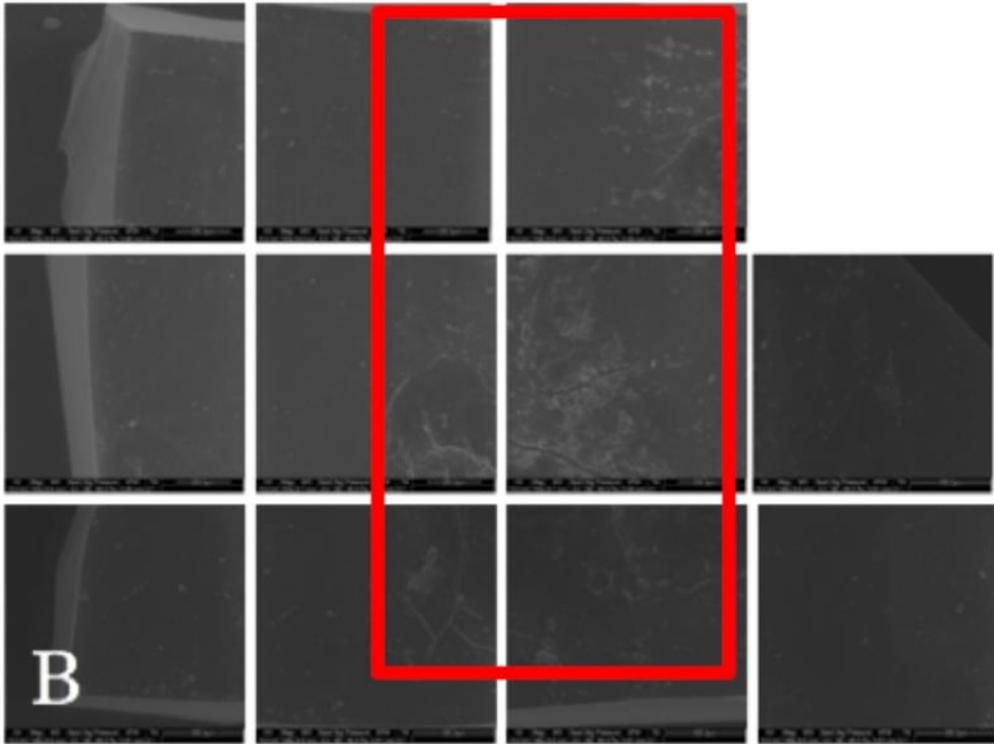
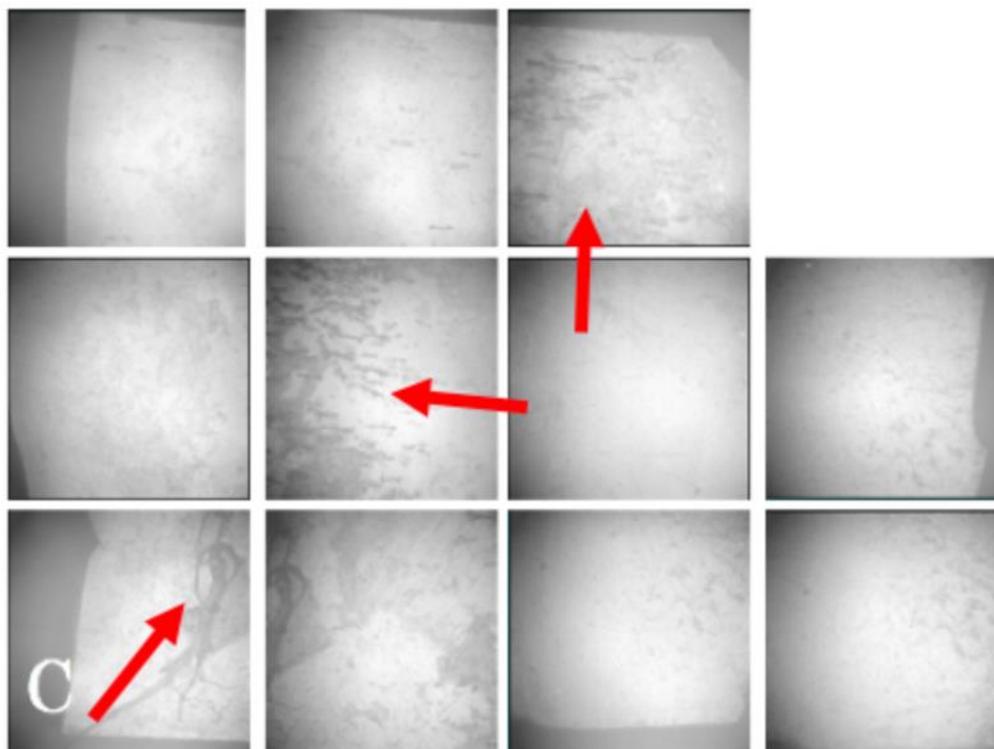
**Figure 45. A large, macroscopic deposit shown by (A) confocal and (B) ESEM. There are residual biologics on (C) the profilometry image of the outlet of Sac 190. (34)**

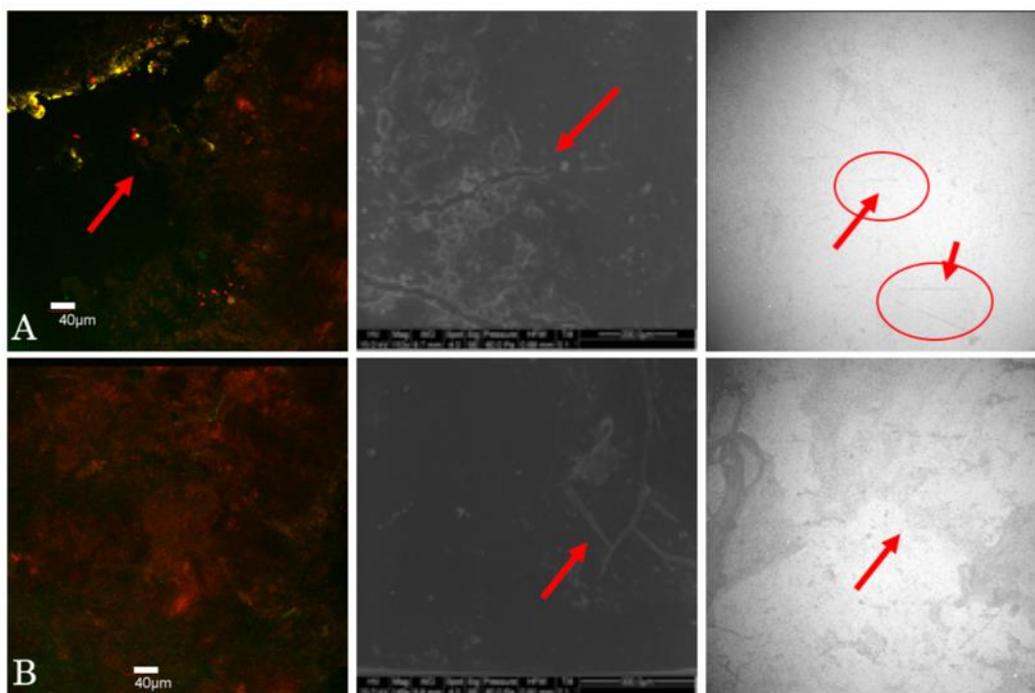
Figure 46. A closer examination of (A) Region 7 and (B) Region 11 of the outlet of Sac 190.  
(34)

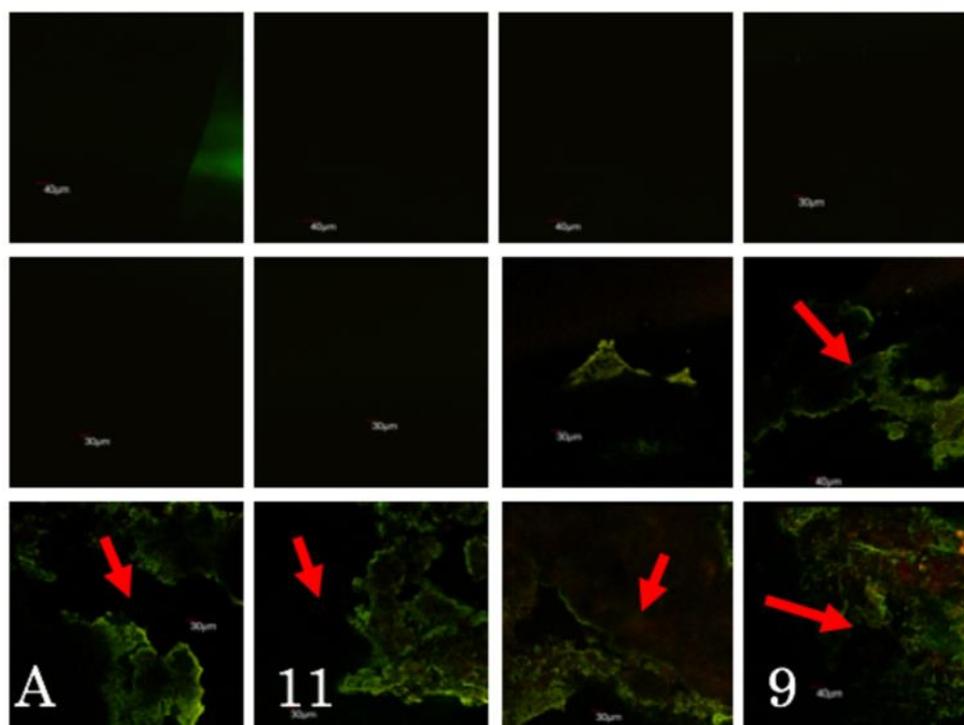
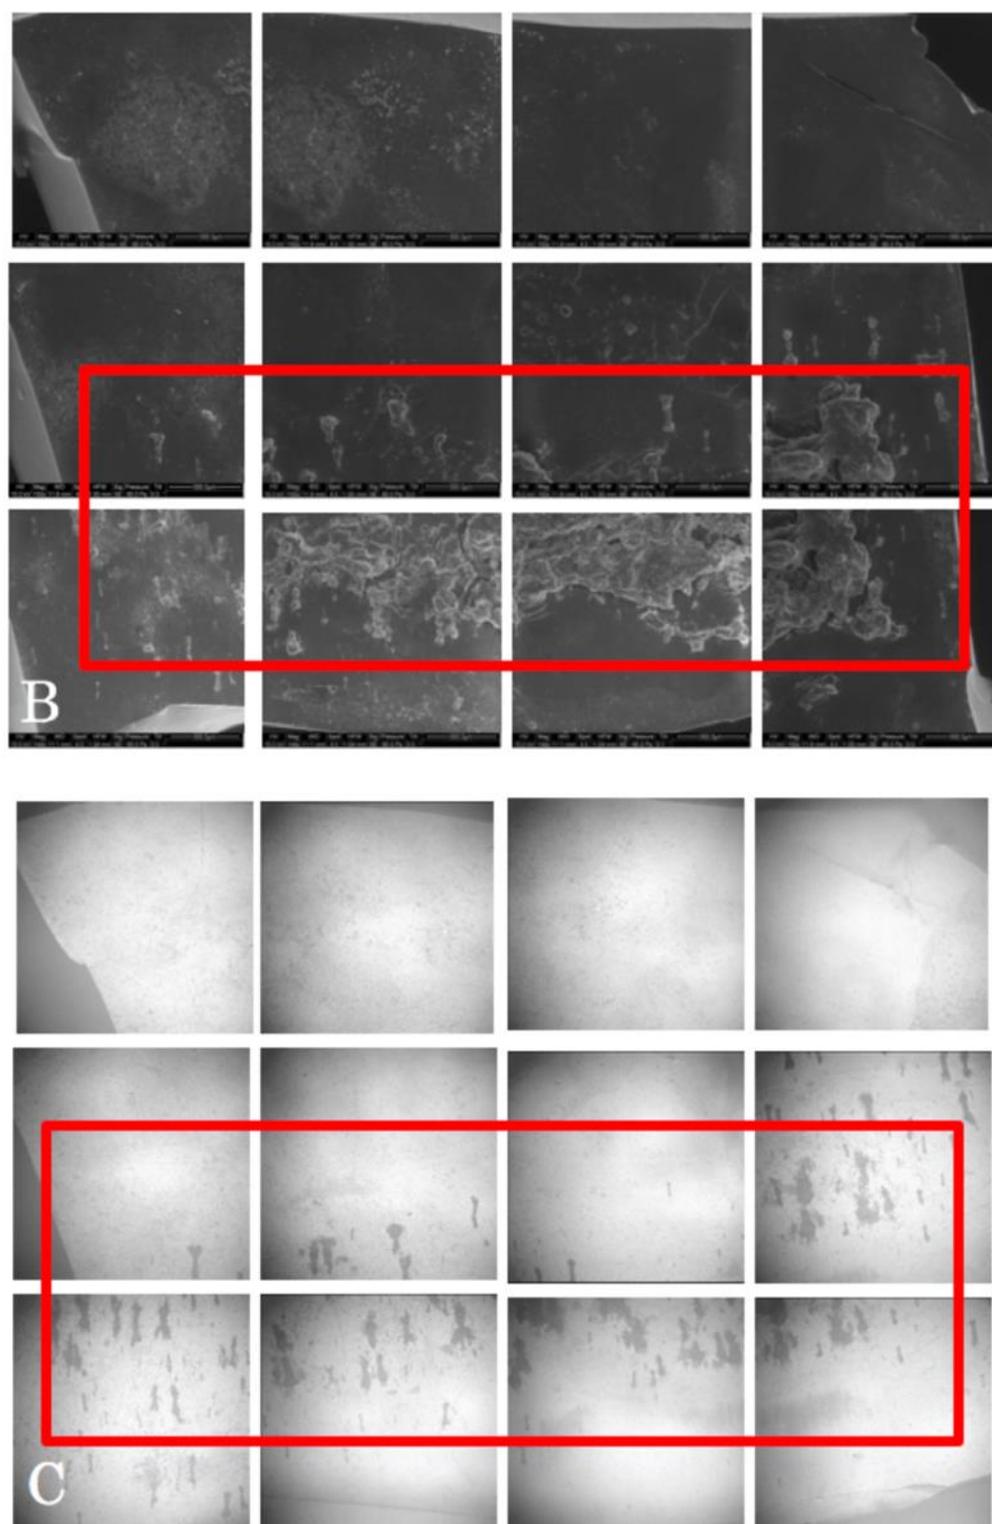
**Figure 47. A dense, macroscopic deposit shown by (A) confocal and (B) ESEM. The (C) profilometry shows residual biologics on the outlet of Sac 234. (34)**

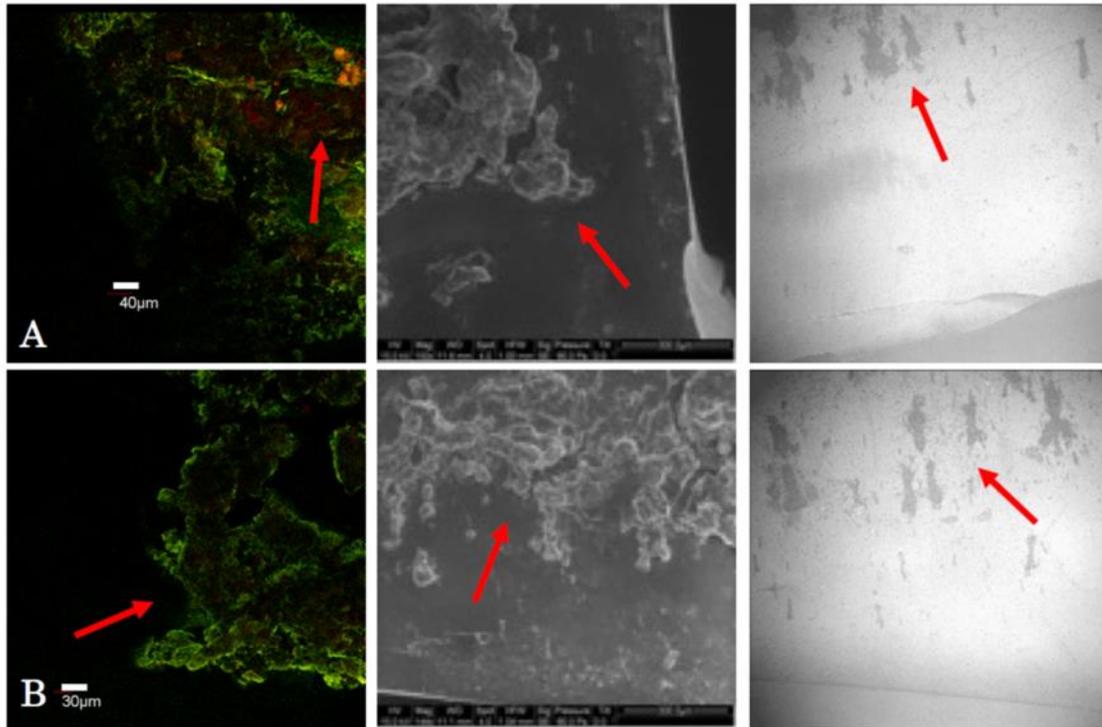
**Figure 48. A closer examination of (A) Region 9 and (B) Region 11 of the outlet of Sac 234.  
(34)**

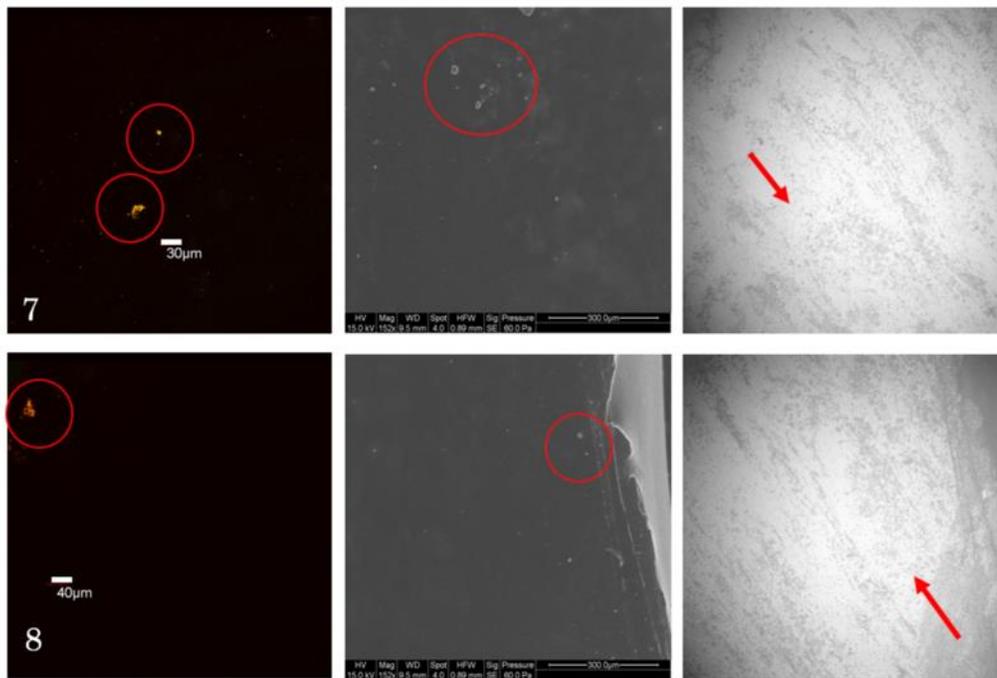
**Figure 49. Small deposits found on confocal and ESEM with the topography showing a scuffed surface on the center front of Sac 170. (A) Region 7 and (B) Region 8 are highlighted. (34)**

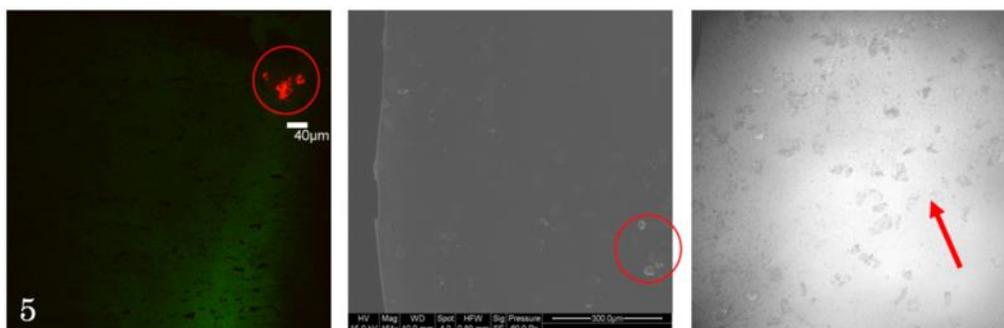
**Figure 50. A small deposit shown by confocal and ESEM at Region 5 on the inlet side of Sac 172. The profilometry image shows debris on the surface. (34)**

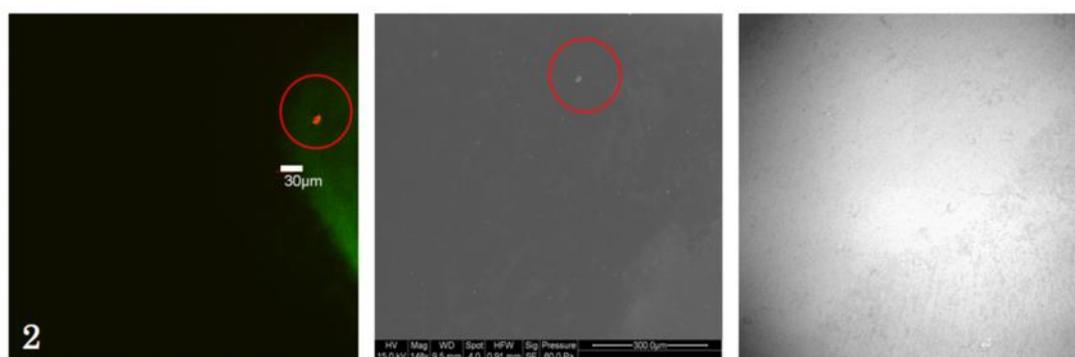
**Figure 51. A small deposit shown by confocal and ESEM on Region 2 of the inlet of Sac 176. The profilometry shows a smooth surface. (34)**

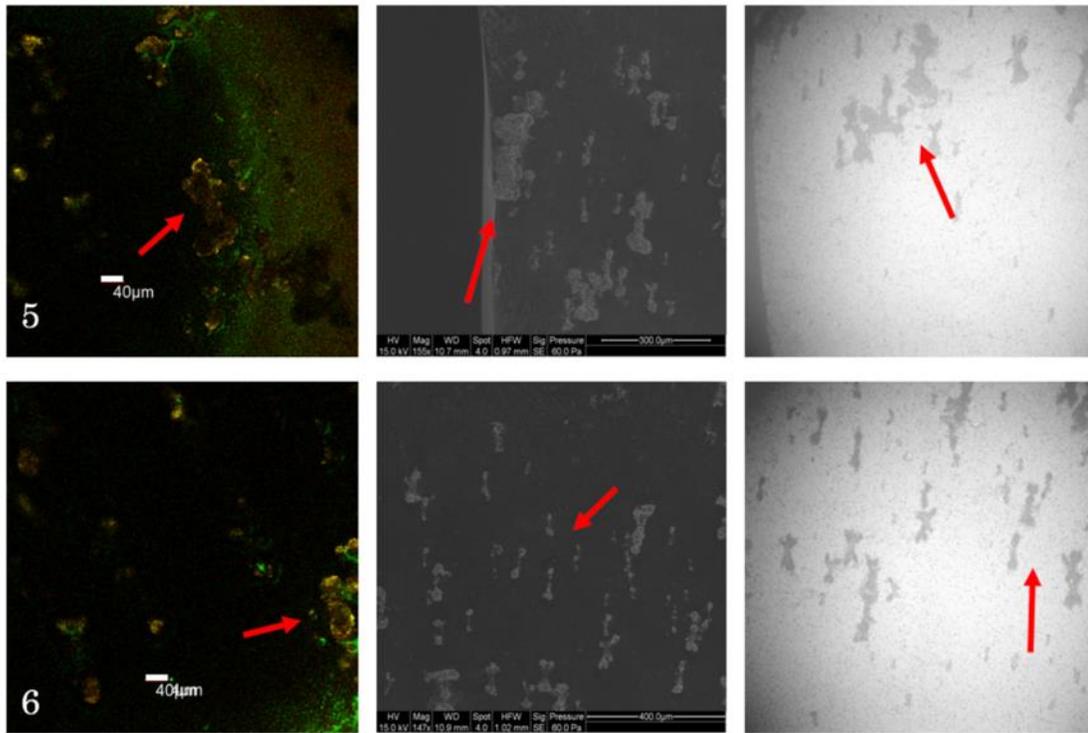
**Figure 52. A large, microscopic deposit was shown by confocal and ESEM on Regions 5 and 6 of the outlet side of Sac 183. The profilometry shows residual biologics. (34)**

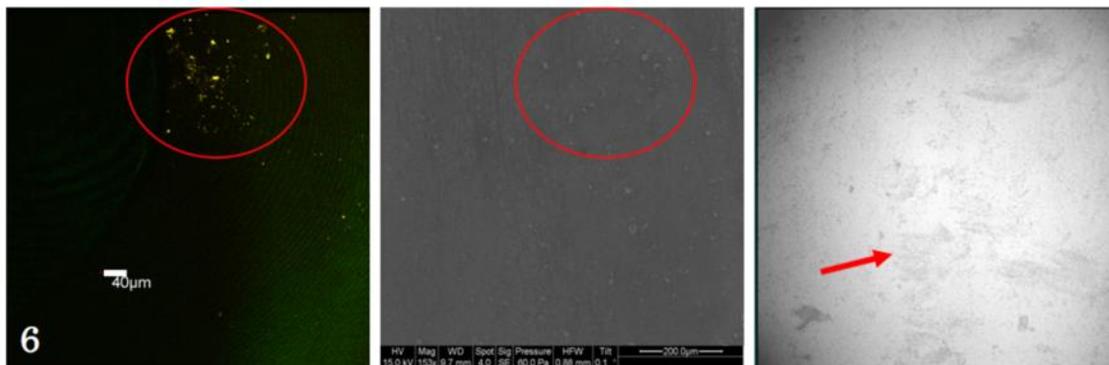
**Figure 53. Yellow, microscopic deposits are shown by confocal and confirmed by ESEM on Region 6 of the center back of Sac 190. The profilometry shows some scuffing on the topography. (34)**

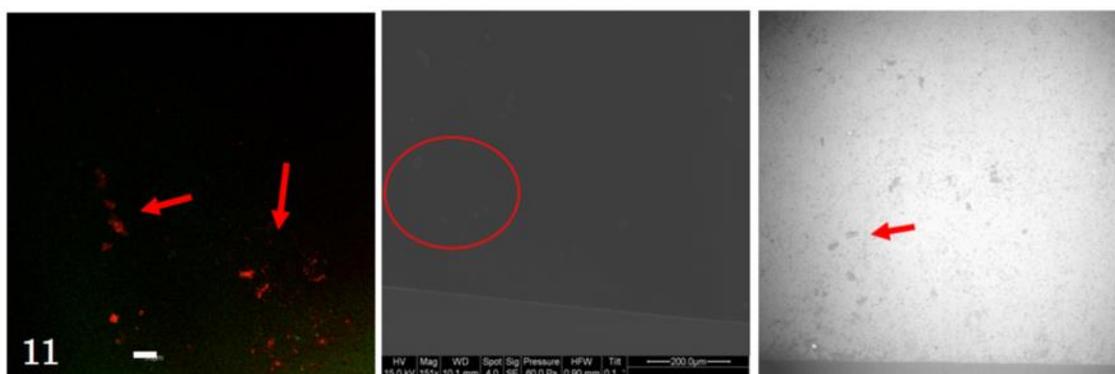
Figure 54. Red deposits are shown by confocal and seen faintly with ESEM on Region 11 of the center back of Sac 192. The topography shows some debris or pitting. (34)

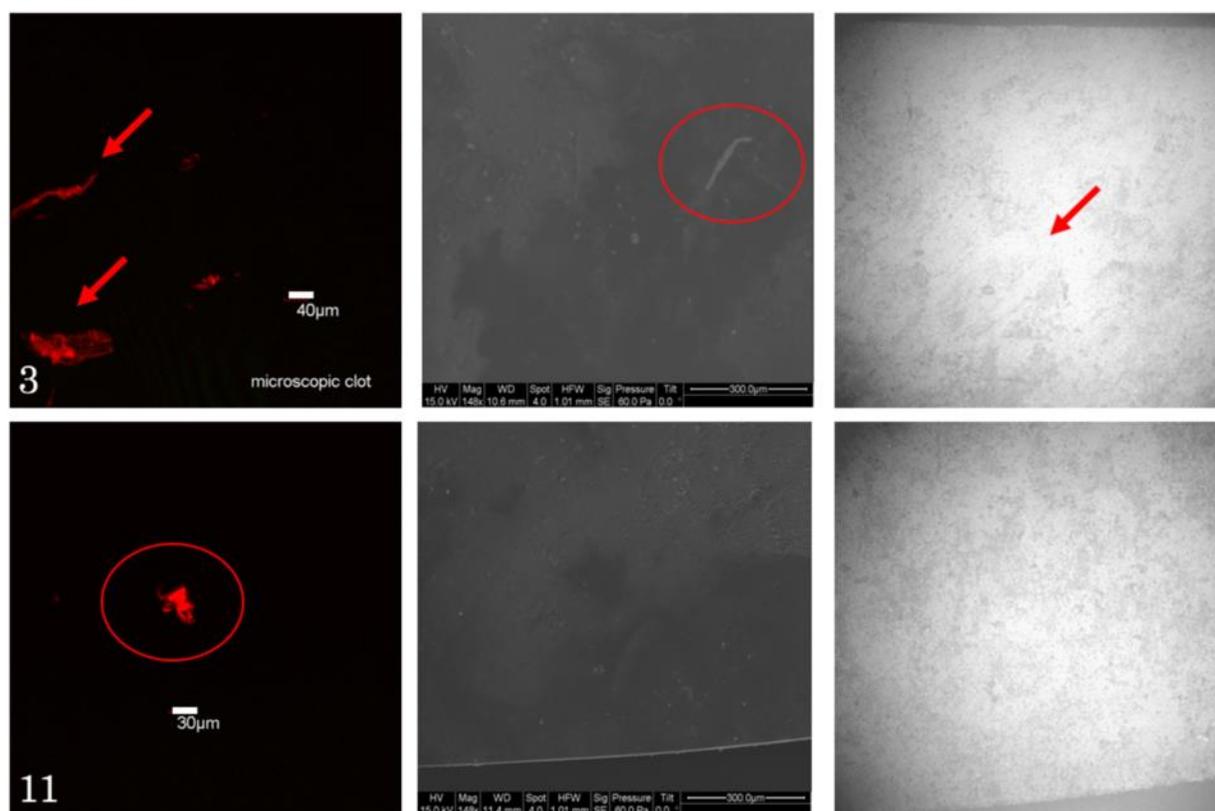
Figure 55. Large, microscopic deposits are shown on confocal and seen faintly on ESEM in Regions 3 and 11 of the top sample of Sac 223. A rougher surface is observed from the profilometry images. (34)

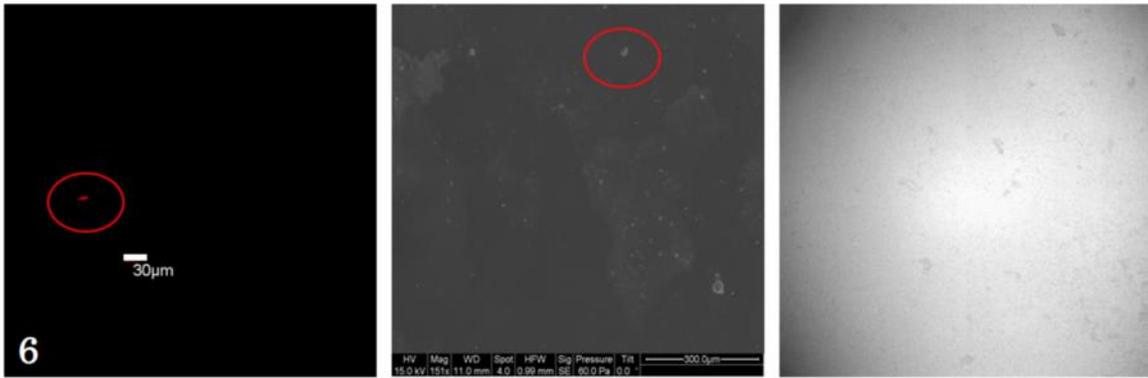
Figure 56. A small, microscopic deposit shown on confocal and confirmed with ESEM on Region of the outlet of Sac 232. The profilometry shows a smooth surface. (34)

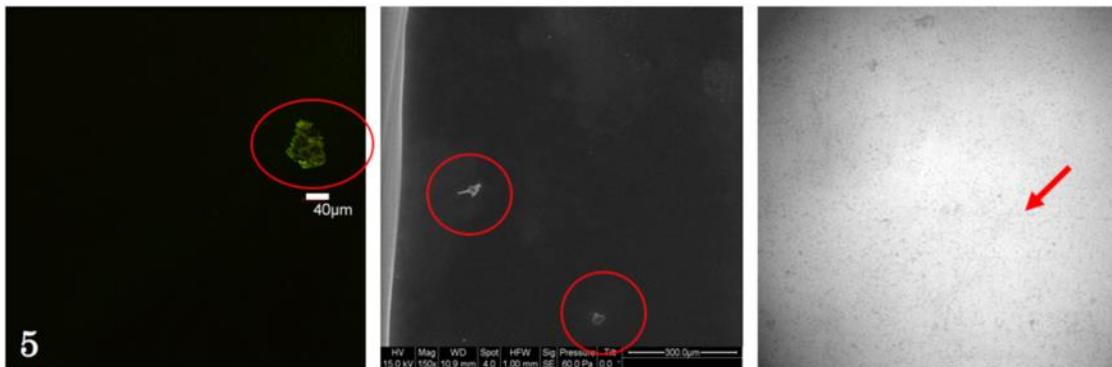
Figure 57. A deposit shown by confocal and confirmed by ESEM on Region 5 of the center front of Sac 234. The red arrow points to a scratch shown on the profilometry image. (34)

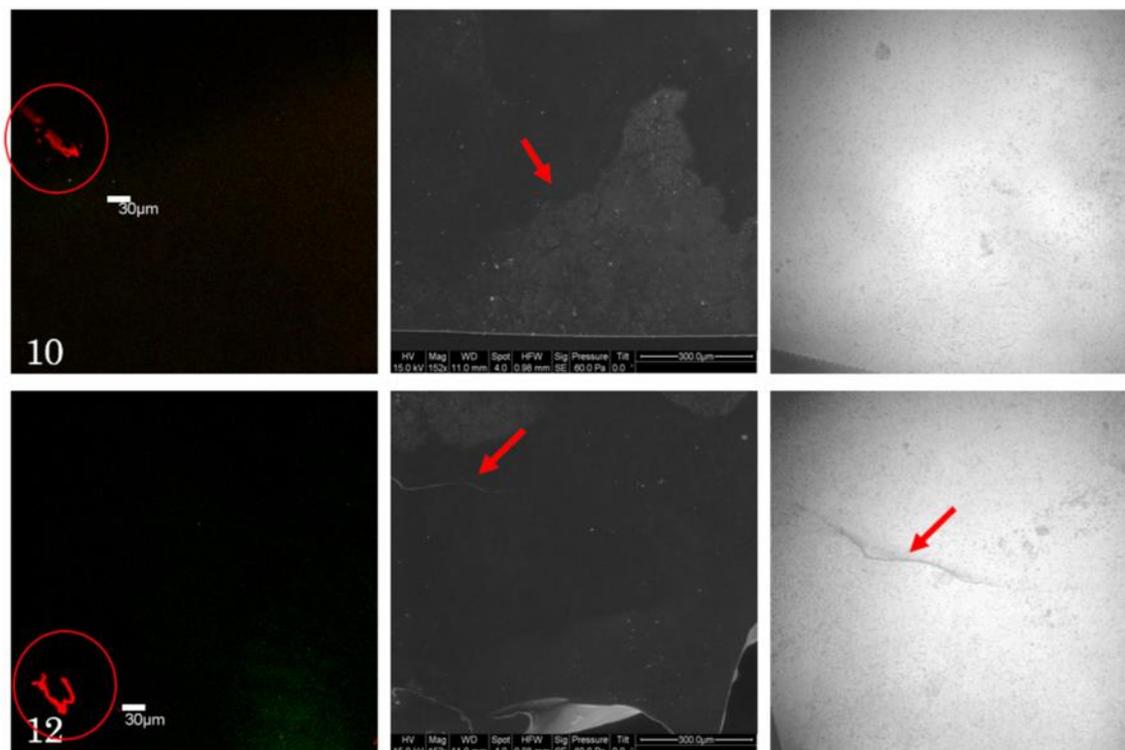
**Figure 58. Red deposits shown by confocal and ESEM on Regions 10 and 12 of the top sample of Sac 247. A divot is shown on the ESEM and profilometry of Region 12. (34)**

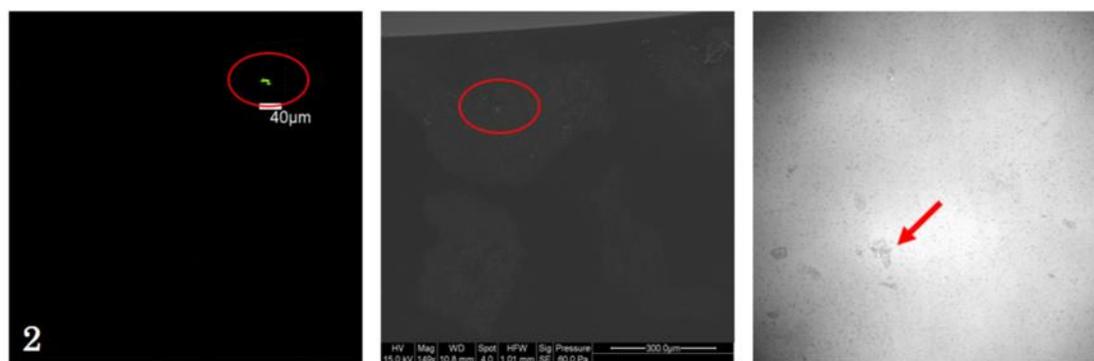
**Figure 59. A small, green deposit is shown on confocal and confirmed with ESEM. The red arrow points to debris on the topography of the profilometry image. (34)**
